Preliminary Engineering Report

Inflow and Infiltration Reduction Improvements

Town of Owasco

June 2021

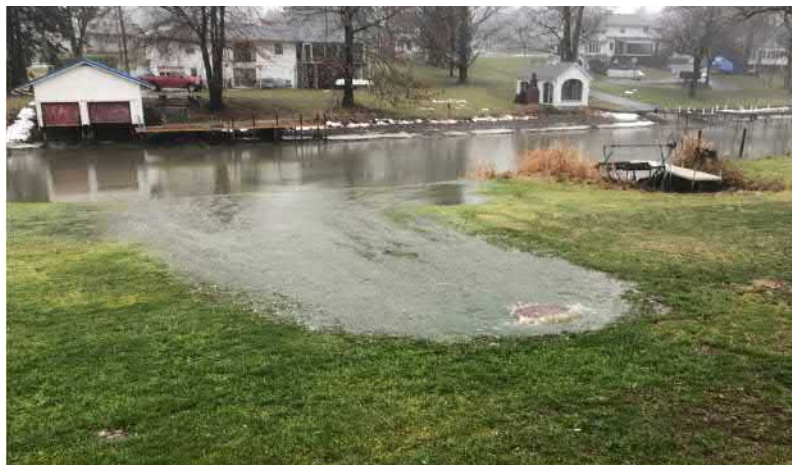
- *Health and Sanitary* – Elevated levels of I-I have led to sewer backups and raw sewage overflows to the Owasco Outlet. The lowest points of the Owasco collection system are adjacent to the Owasco outlet. During sewer overflows, untreated sewage flows directly into the outlet as shown in the photo below. This is a serious health and environmental concern. The location of these overflows are in extremely close proximity to Owasco Lake, an “Impaired” waterbody on the NYSDECs Priority Waterbody List (PWL), and occur within residential yards. Elevated Town flows also compound capacity issues and CSO's within the City of Auburn conveyance system downstream of the Town's connection near Swift Street.

Manhole along Owasco Interceptor Overflowing into Owasco Outlet

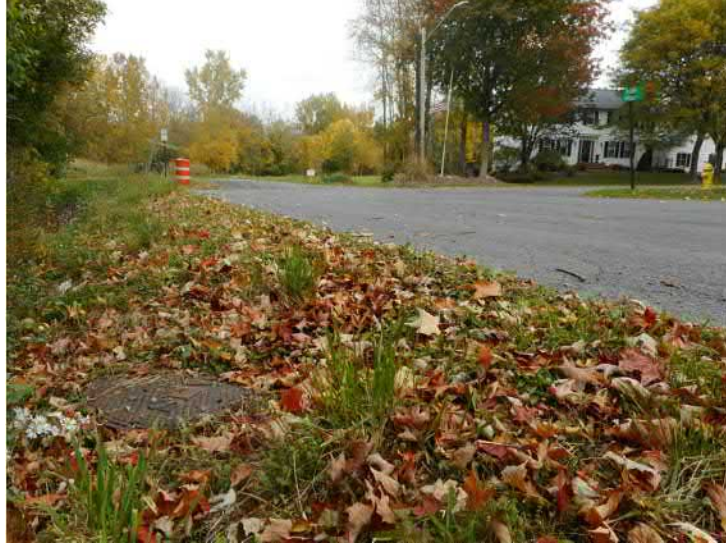
Manhole 7-13: Low Lying Manhole Cover

- b. Sub Area No. 6: 27, 41
 - c. Sub Area No. 7: 10, 12 13
 - ii. Recommended Rehabilitation Action: Raise Manhole Cover. Operators should raise low lying or buried/paved over manhole covers to or above the surrounding grade so that stormwater cannot pond on or flow over into the manhole covers. Almost every inspected manhole cover had open pick holes and none of them were water tight. As noted in the table below, ponding or heavily flowing water over any low lying manhole cover can lead to direct inflow. The most effective method for correcting this deficiency is to raise the top of the manhole. The picture below shows workers raising the top of a manhole cover with a manhole riser ring within a paved area.

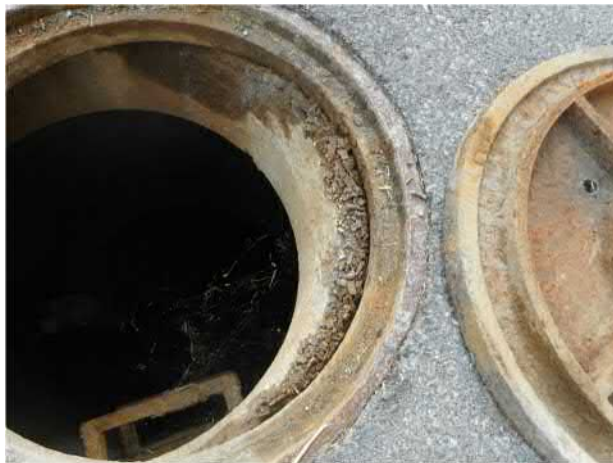
- Deficiency: Offset Manhole Frame and Cover
 - i. Manhole Numbers:
 - a. Sub Area No. 1: 2
 - b. Sub Area No. 2: 6
 - c. Sub Area No. 4: 21
 - d. Sub Area No. 5: 4, 16, 27
 - e. Sub Area No. 6: 33
 - f. Sub Area No. 7: 1
 - ii. Recommended Rehabilitation Method: Remove and Reset Frame.
 - iii. Alternative to Recommendation: There is no sensible alternative to the above listed rehabilitation recommendation.

Manhole 5-27: Offset Frame

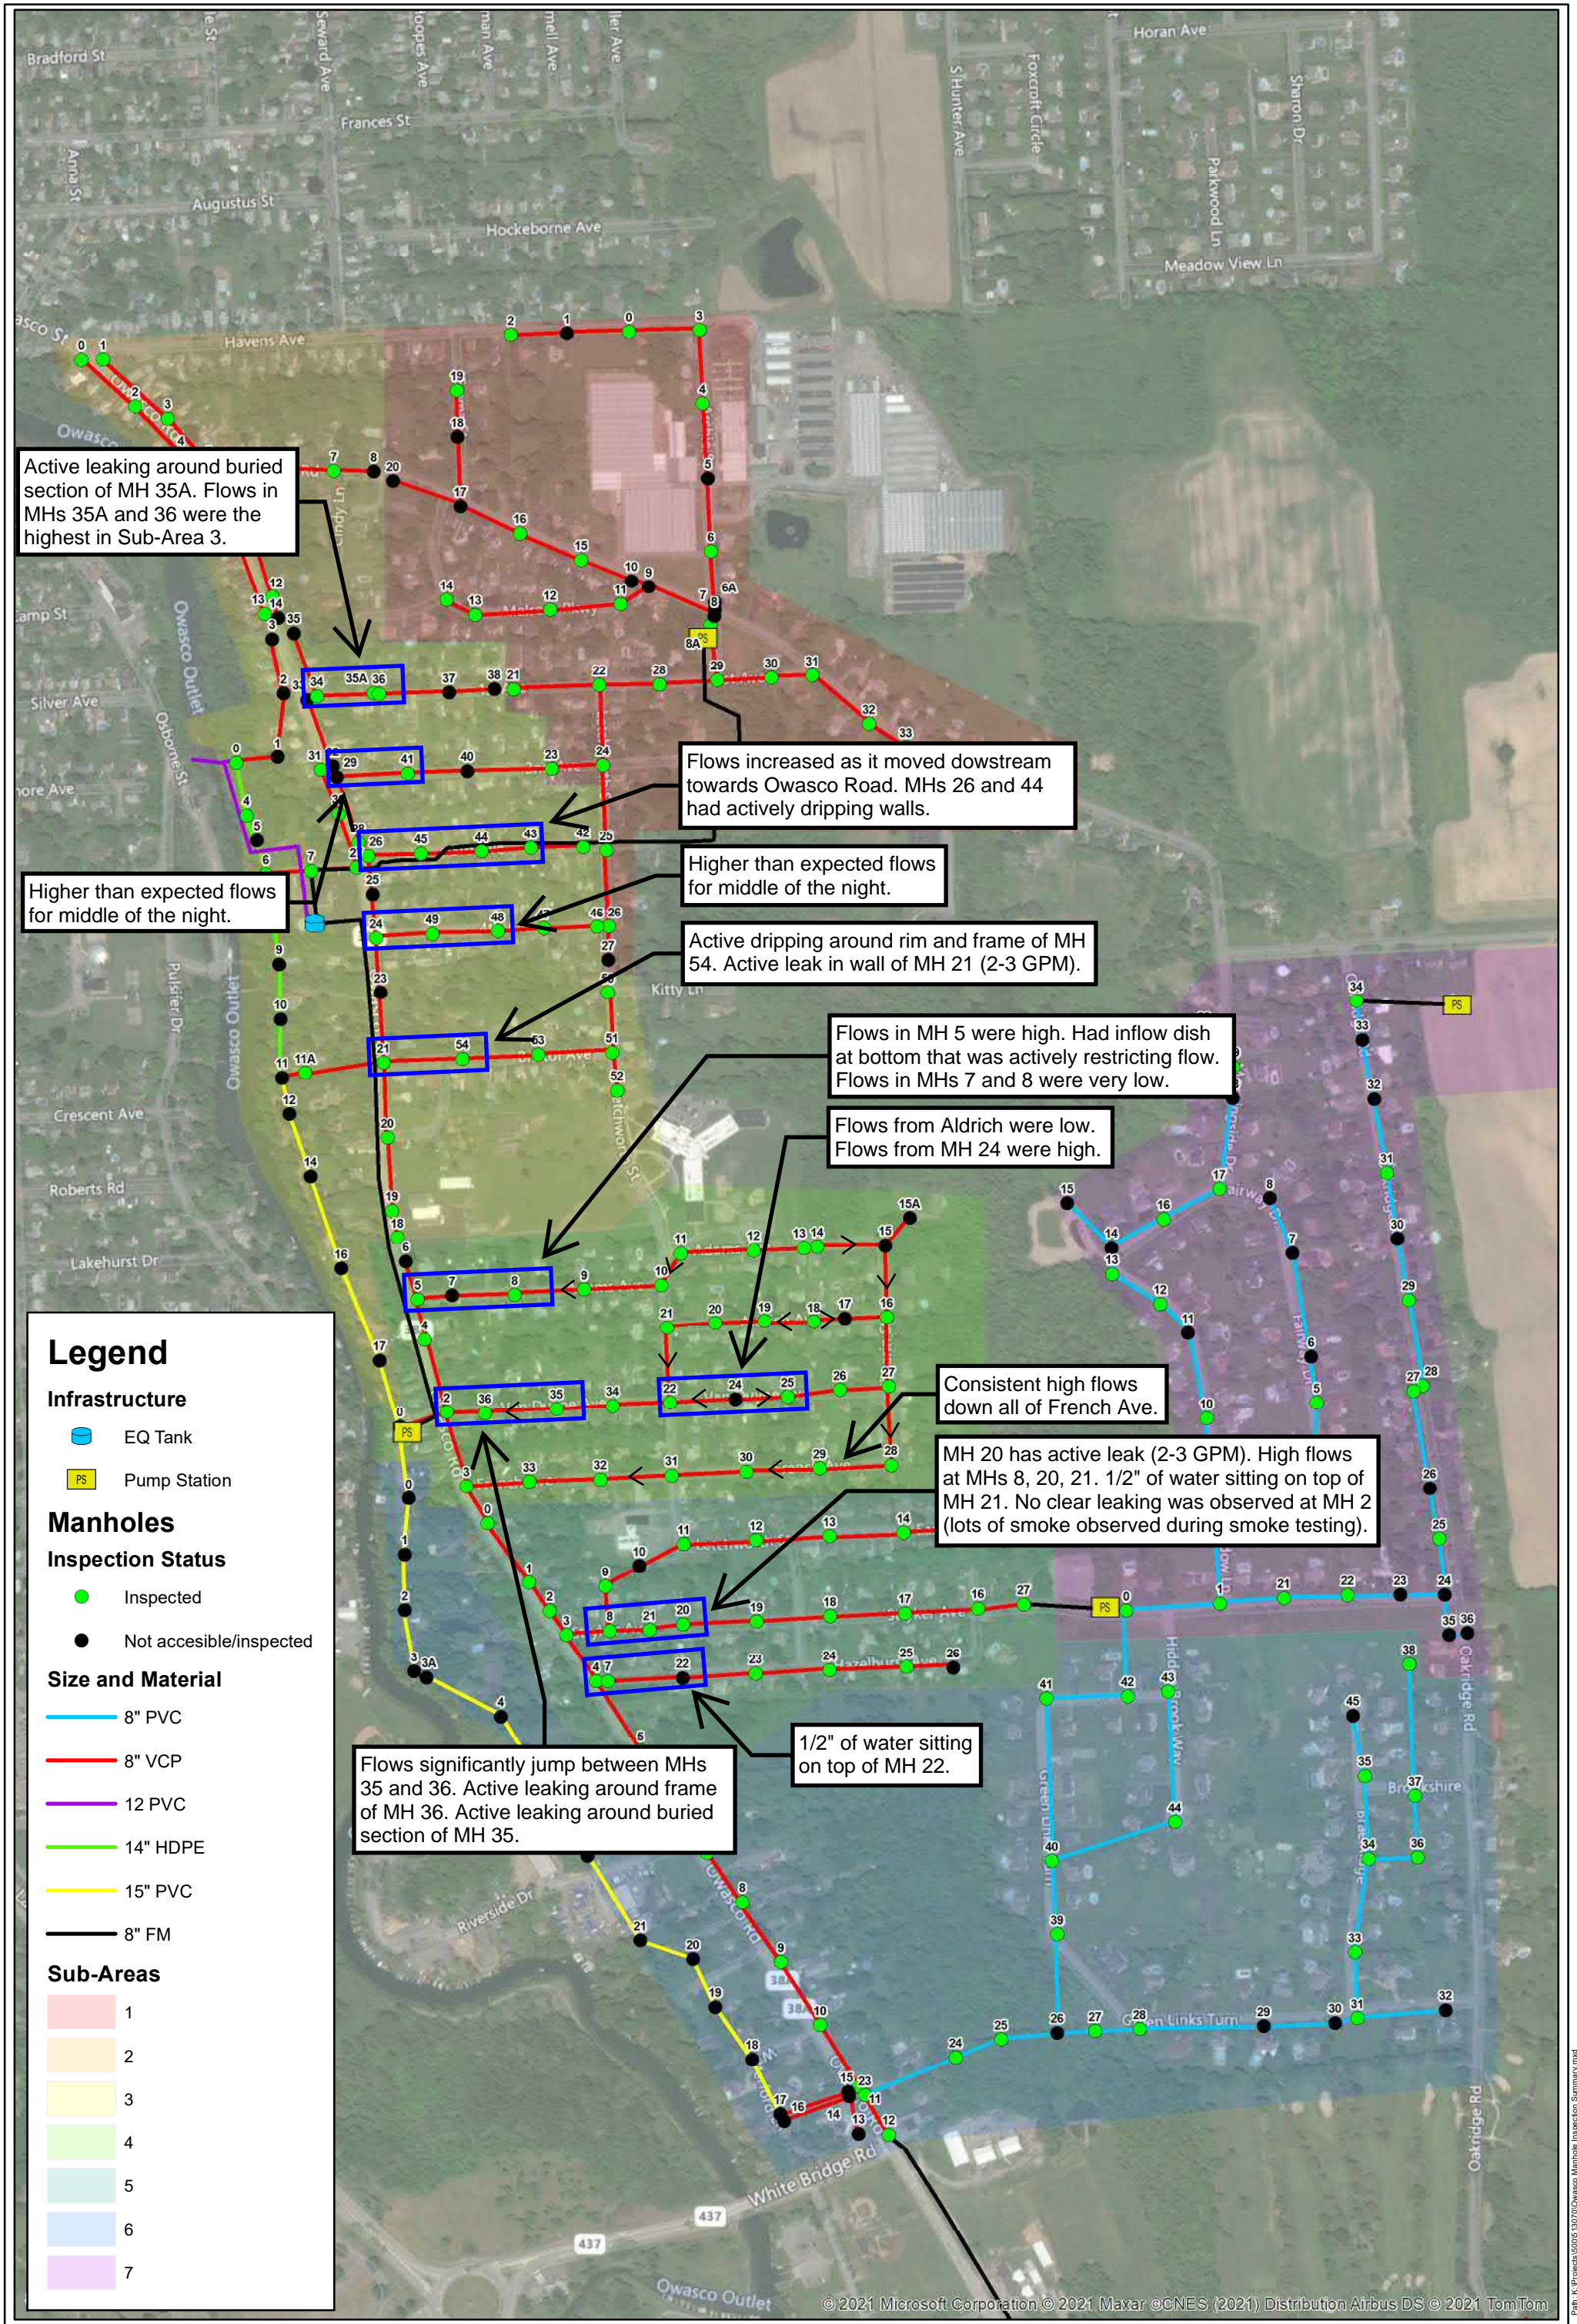
Figure 5
Wet Weather/Night-time Flow Observations

Active leaking around buried section of MH 35A. Flows in MHs 35A and 36 were the highest in Sub-Area 3.

Flows increased as it moved downstream towards Owasco Road. MHs 26 and 44 had actively dripping walls.

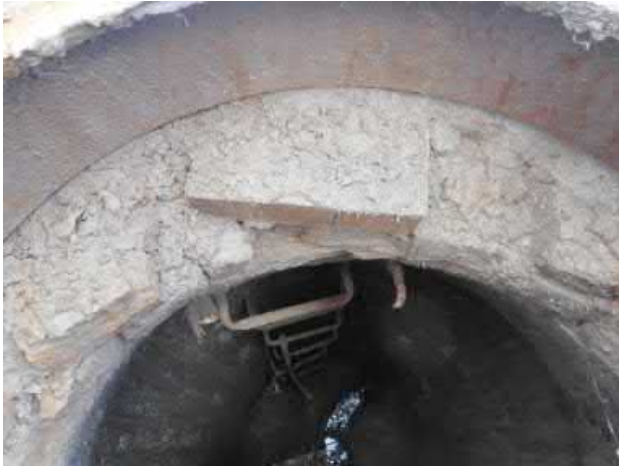
Manhole No. 1-0

- Possible abandoned lateral up wall
- Unknown hose connection
- Deteriorated riser
- Streaking on wall under steps, possible leak

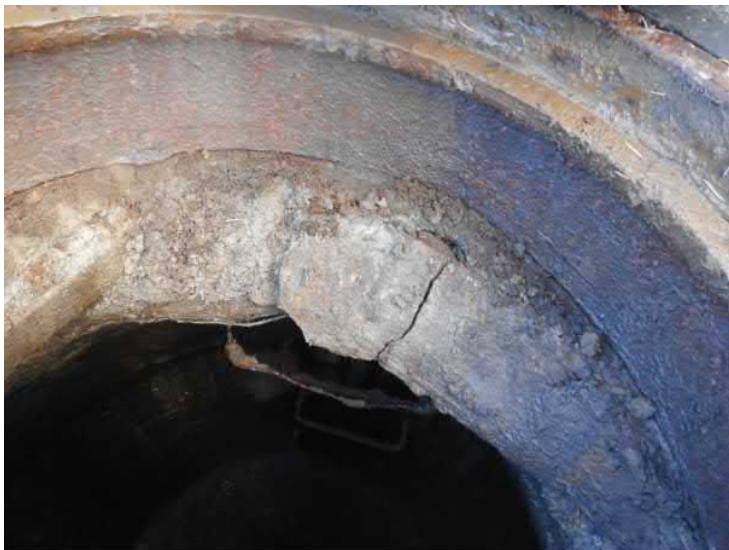
Manhole No. 1-2

- Lots of streaking on walls showing evidence of I/I
- Inflow dish with holes
- Deteriorated riser

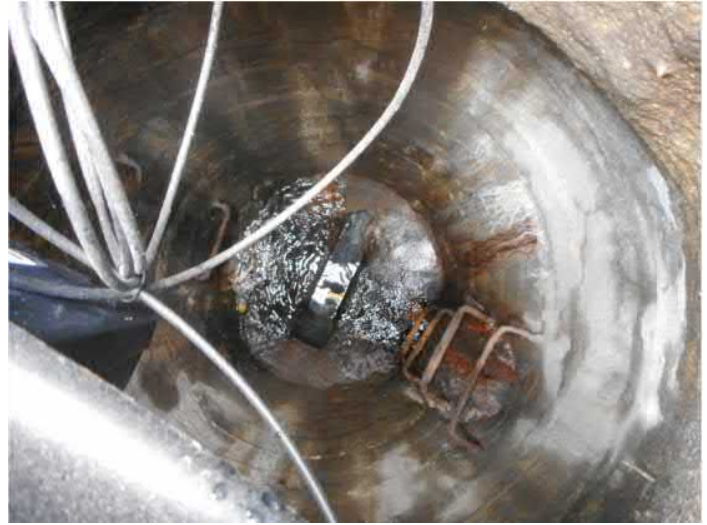
Manhole No. 1-4

- Very wet bench, potential active leak at wall/bench connection
- Streaking on walls from single wall joint

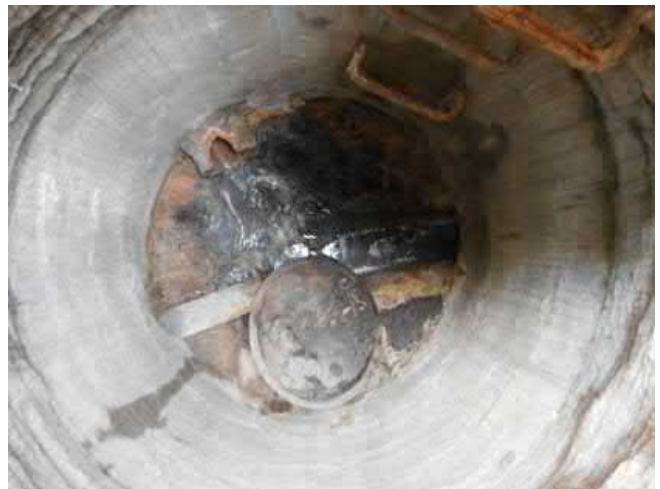
Manhole No. 1-11

- Inflow dish has fallen to bottom of manhole
- Channel in poor condition

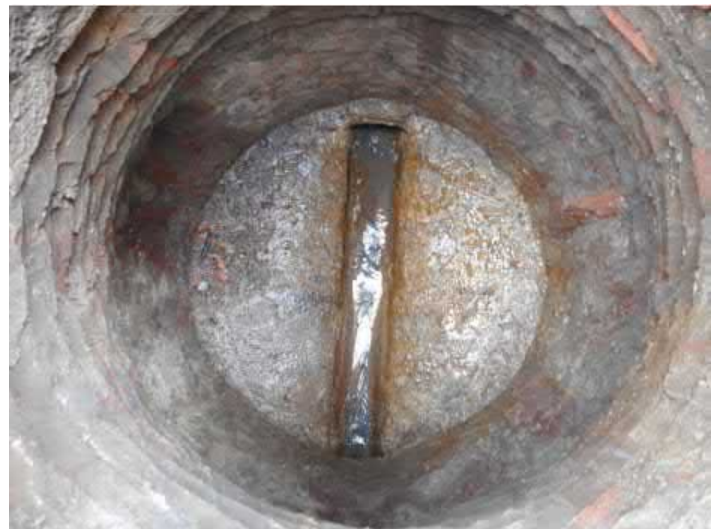
Manhole No. 1-12

- Lots of water sitting on bench, most likely from streaking down walls
- Brick manhole with lots of sediment buildup around walls

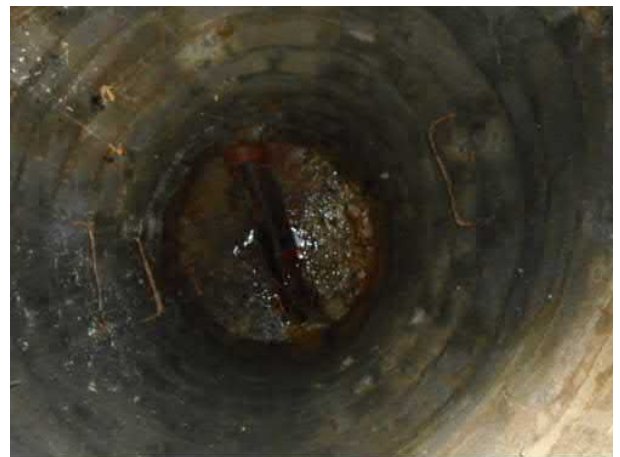
Manhole No. 1-26

- Water leaking in through joints and pipe penetrations

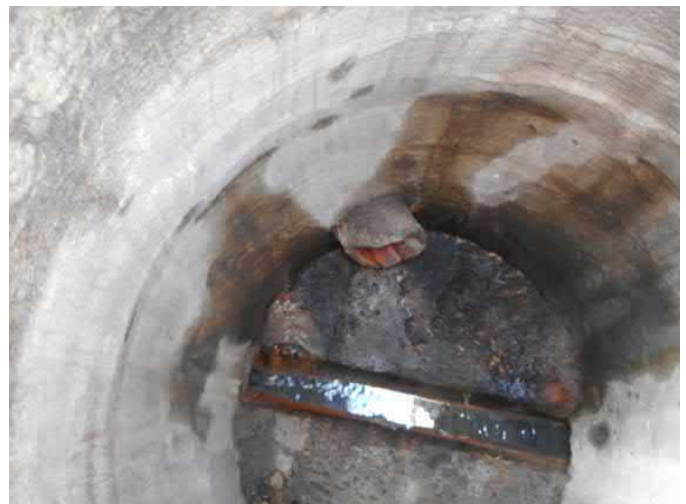
Manhole No. 1-32

- Abandoned pipe on wall, possible from nearby storm culvert

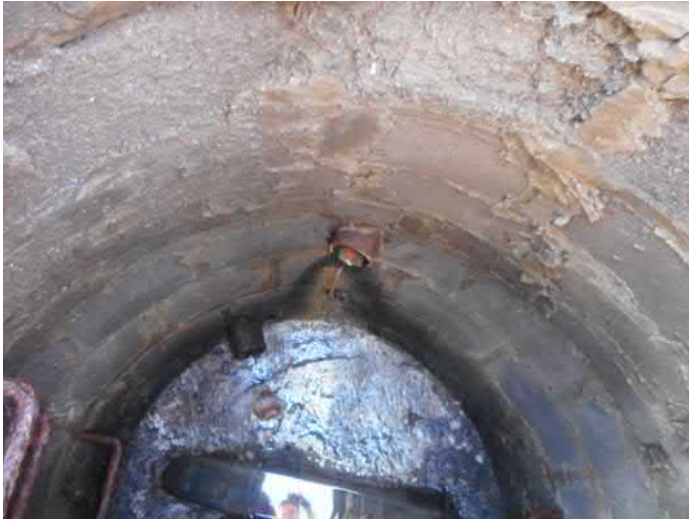
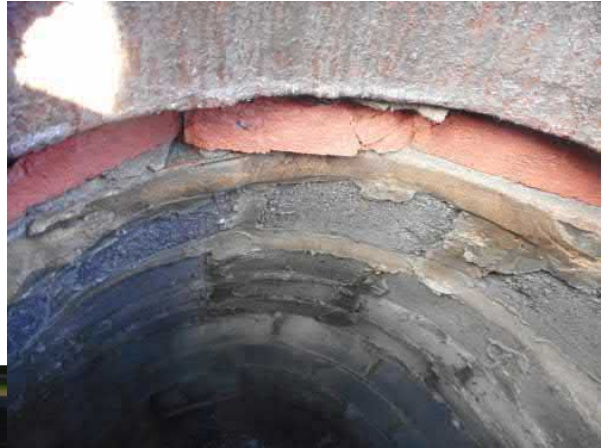
Manhole No. 2-2

- Leak around lateral penetration up the wall
- Water leaking through brick riser

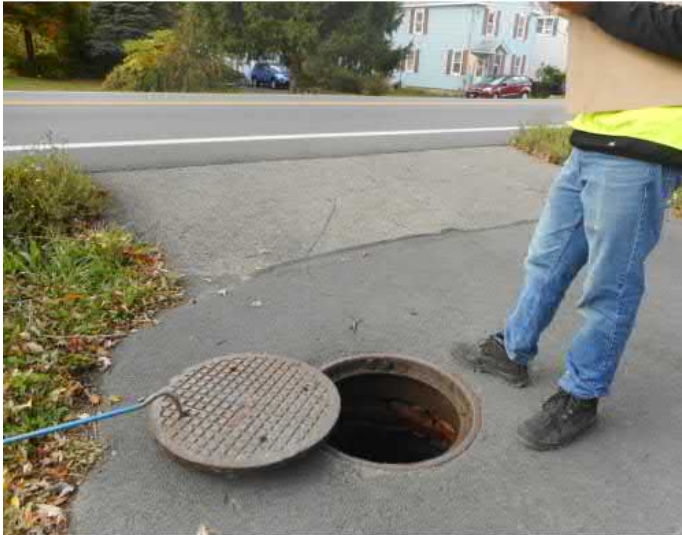
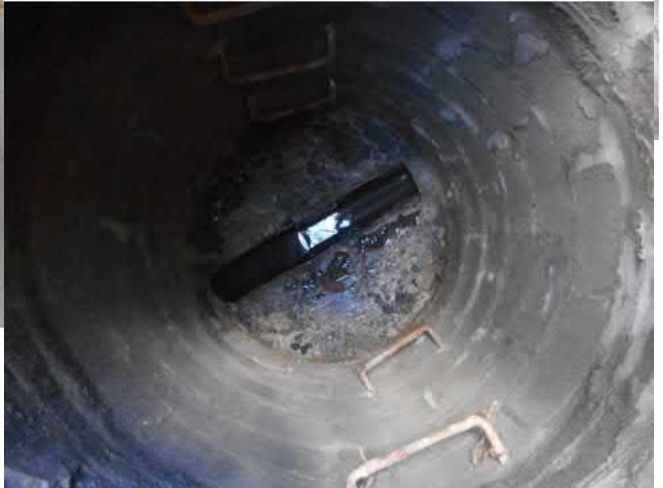
Manhole No. 2-3

- Water leaking through brick riser
- Potential for ponding from road runoff

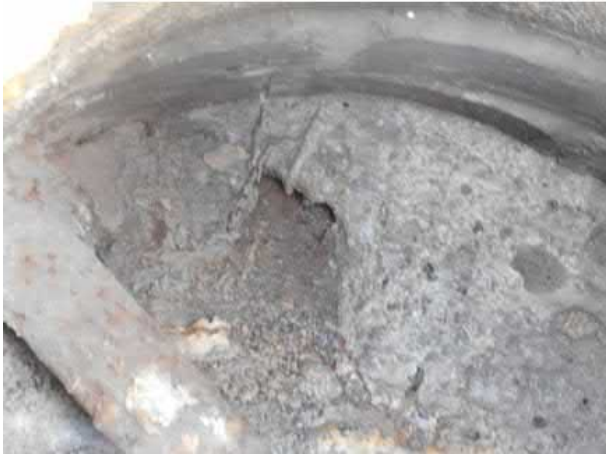
Manhole No. 2-6

- Past lining starting to deteriorate
- Frame/riser in poor condition
- Leak on bench

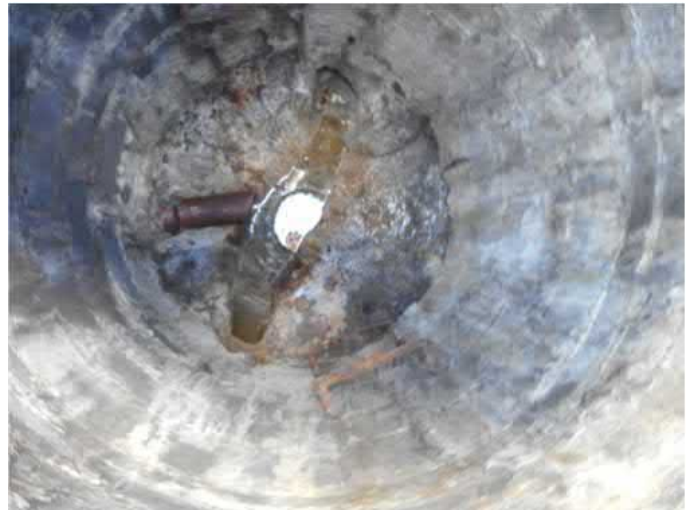
Manhole No. 2-11

- Potential for ponding
- Leak at wall joints
- Deteriorated and leaking walls

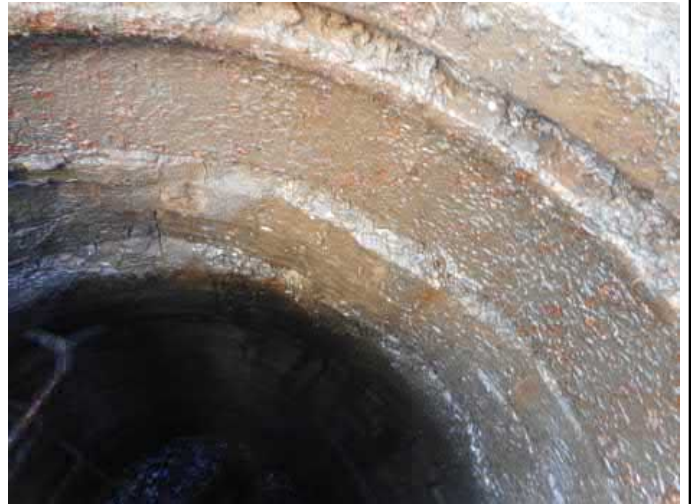
Manhole No. 3-20

- Potential for ponding
- Leaking through frame/riser

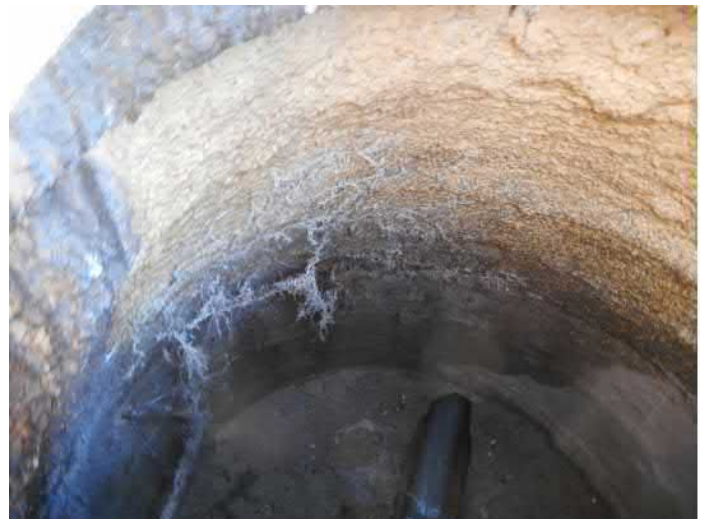
Manhole No. 3-34

- Roots penetrating through frame and walls
- Deterioration of frame

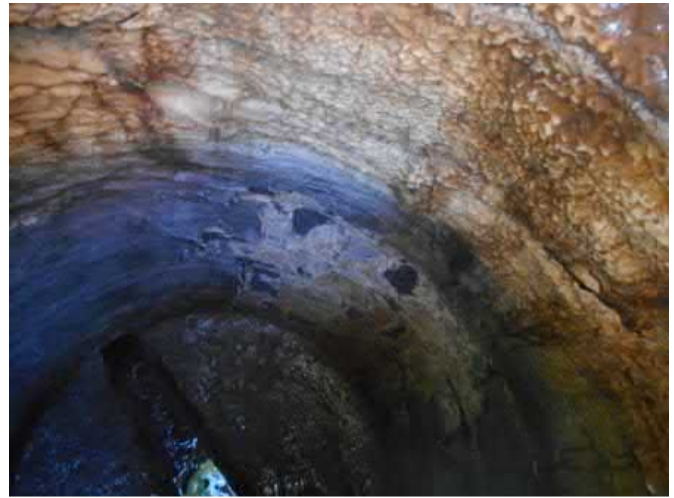
Manhole No. 3-43

- Past lining fully deteriorated

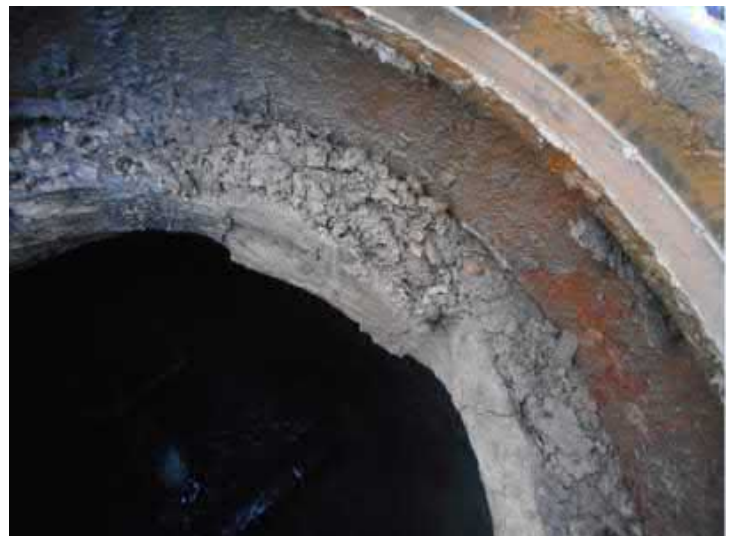
Manhole No. 3-47

- Large sediment buildup on riser/frame joint
- Active leak around lateral penetration (not pictured)

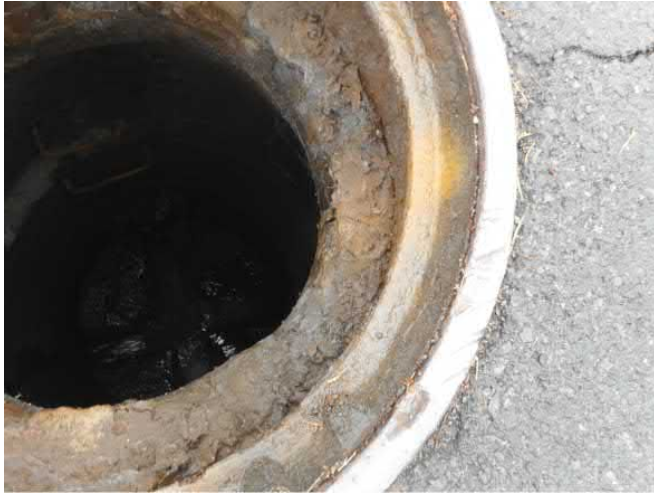
Manhole No. 4-2

- Three abandoned pipes along wall
- Frame/riser in poor condition

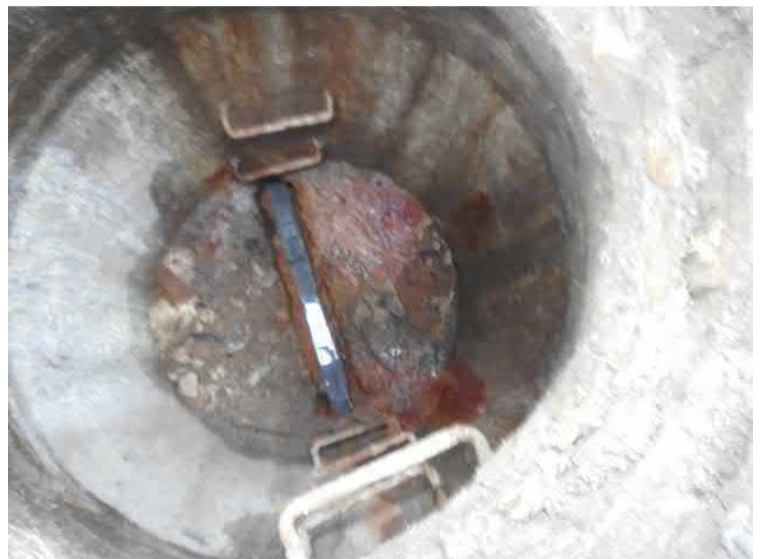
Manhole No. 4-19

- Debris on bench
- Deteriorated frame/riser

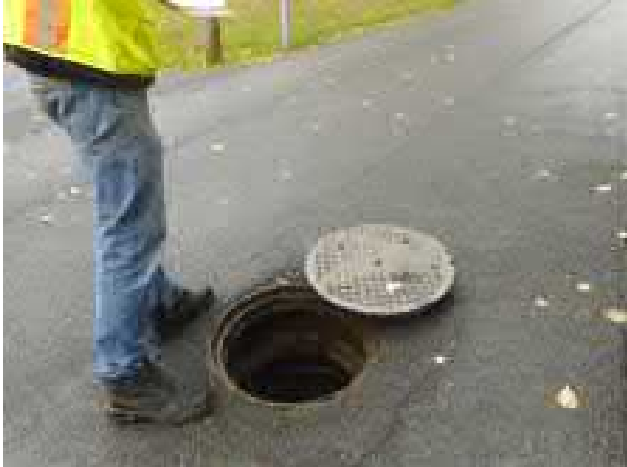
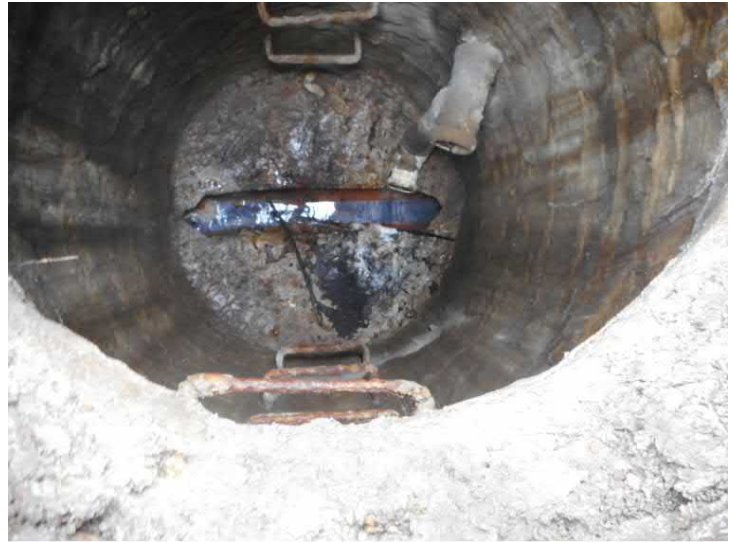
Manhole No. 4-20

- Leaking around riser
- Debris on bench and channel

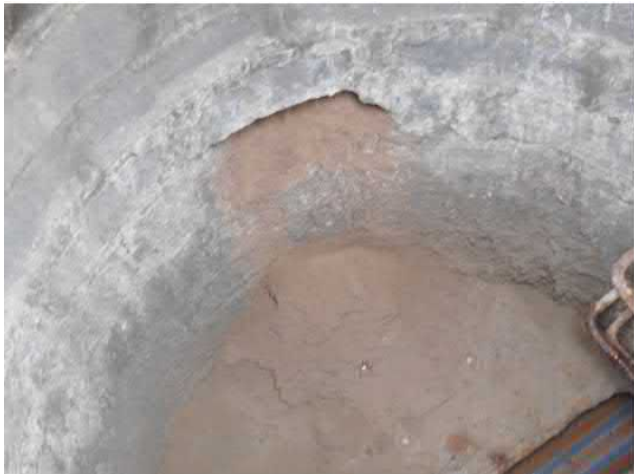
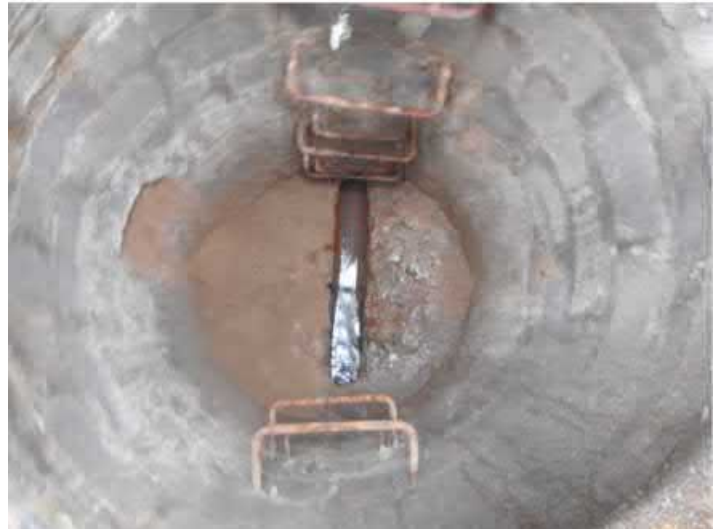
Manhole No. 4-32

- Block from wall has fallen onto bench
- Deterioration of rest of wall

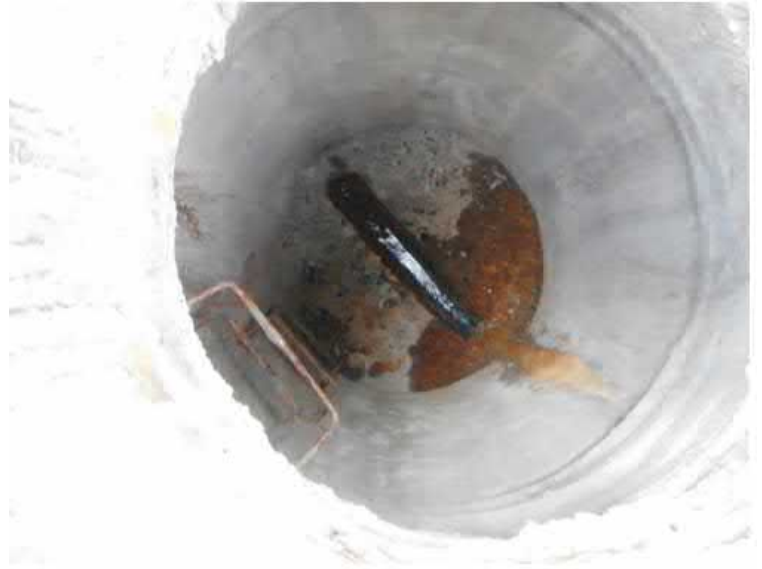
Manhole No. 5-13

- Streaking from leak on wall
- Lots of debris on bench

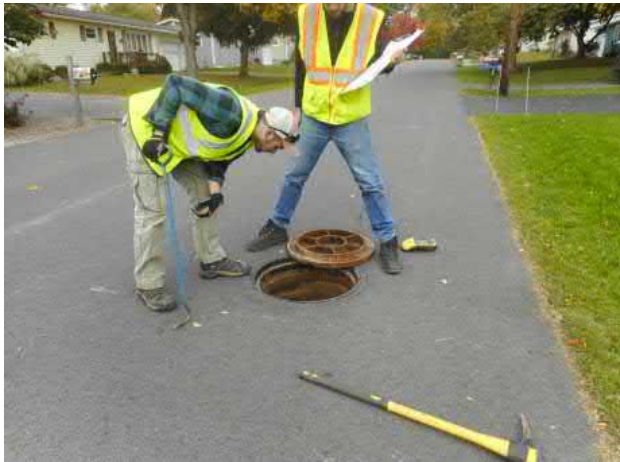
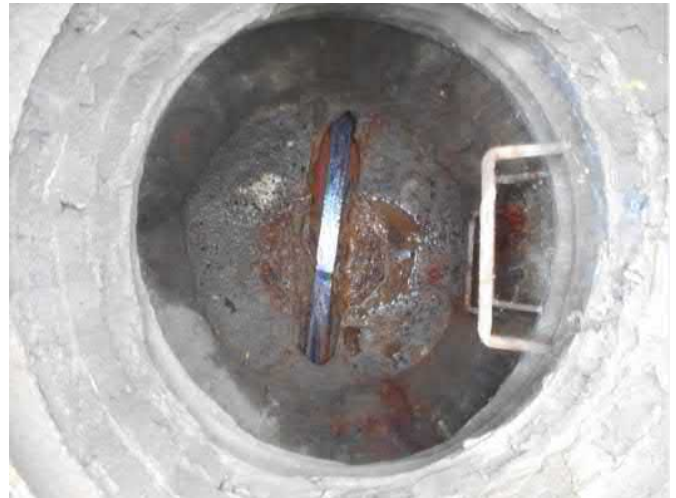
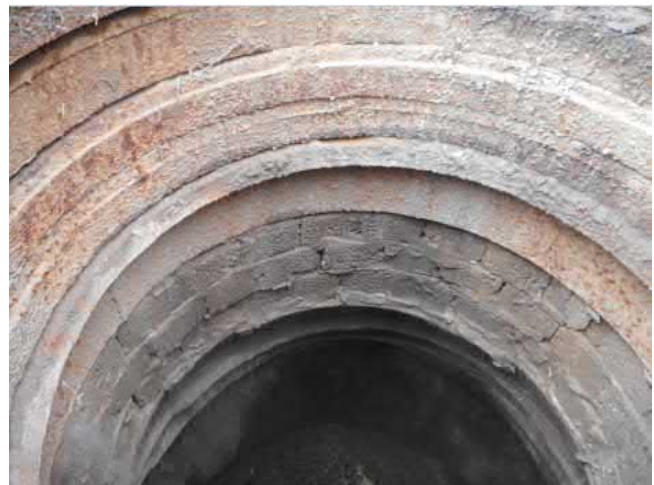
Manhole No. 5-14

- Sediment buildup on layers of risers
- Previous lining deteriorating

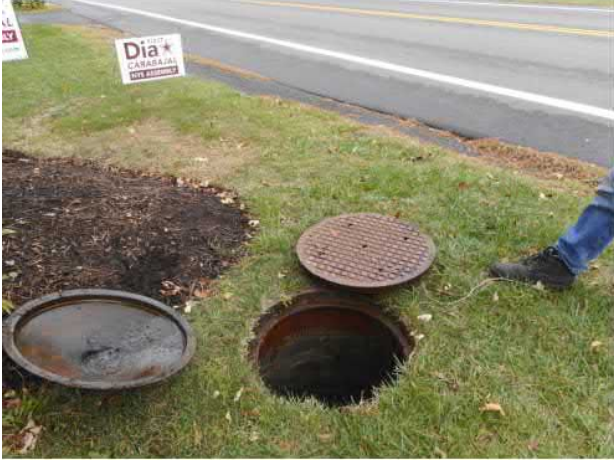
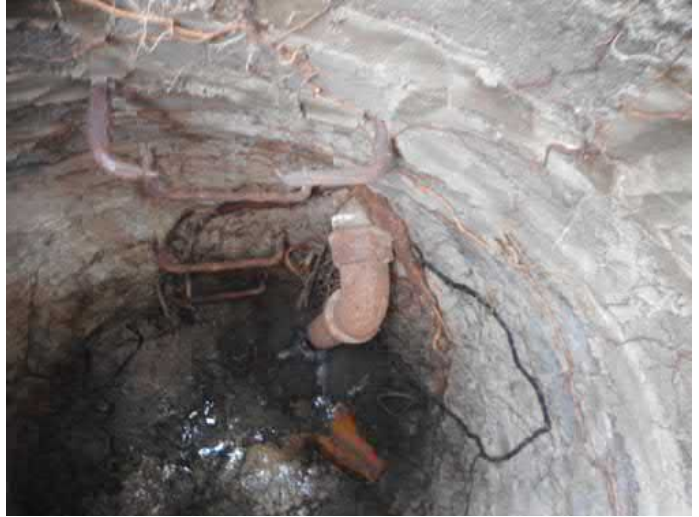
Manhole No. 6-7

- Roots penetrating through walls around lateral
- Sediment buildup around frame/riser

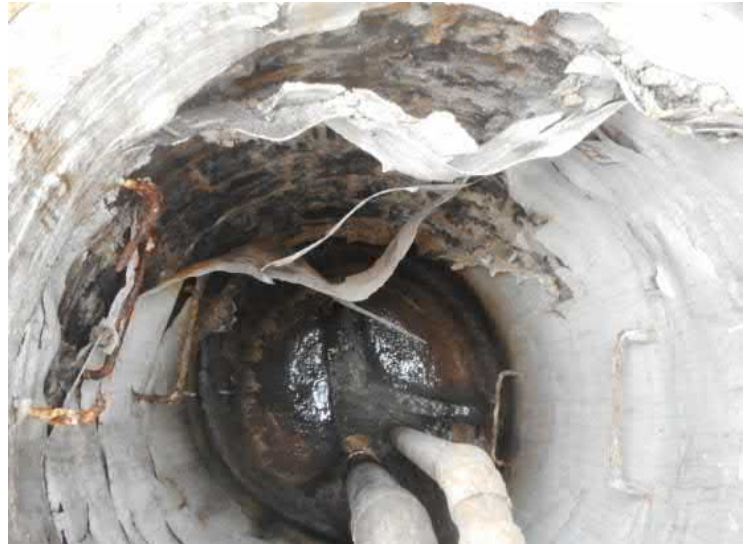
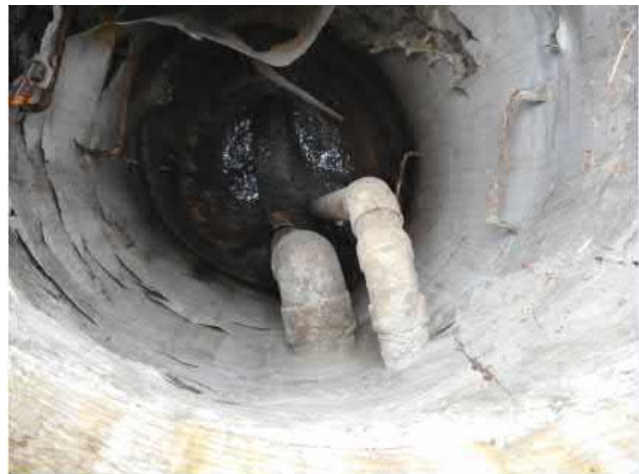
Manhole No. 6-12

- Receives force main from Sewer District 2
- Old lining falling completely peeling off
- Bench and channel in poor condition

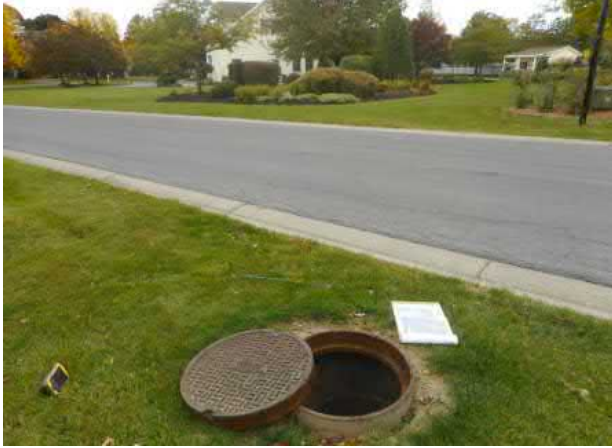
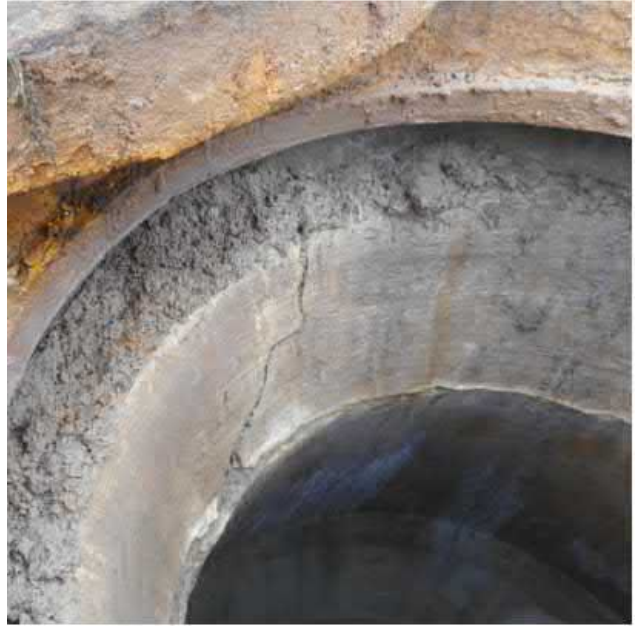
Manhole No. 6-33

- Large crack in frame
- Frame offset ~2 inches

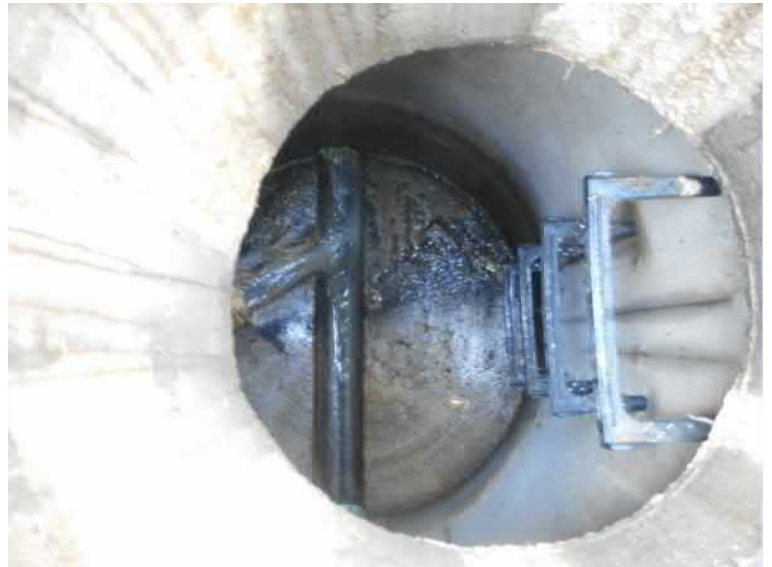
Manhole No. 6-40

- Streaking below steps, potential active leak at bench/wall joint
- Leaking around joints of wall/corbel

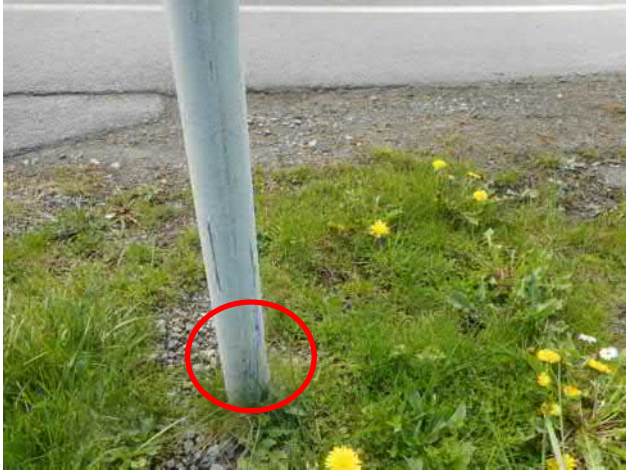
7308 Owasco Road - Faint smoke from base of street sign. Likely from crack in sewer pipe.

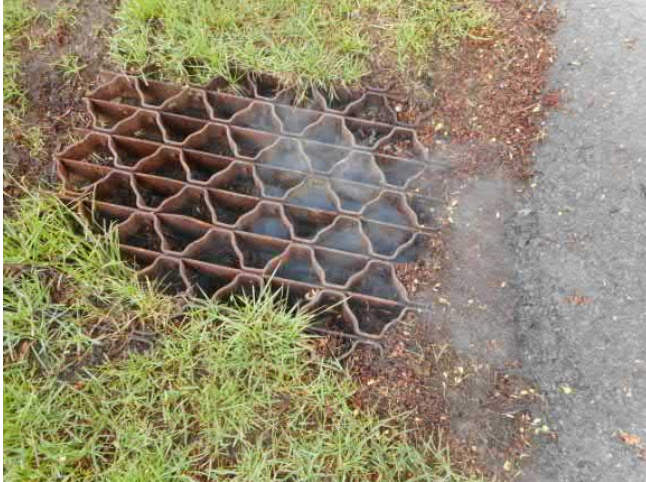
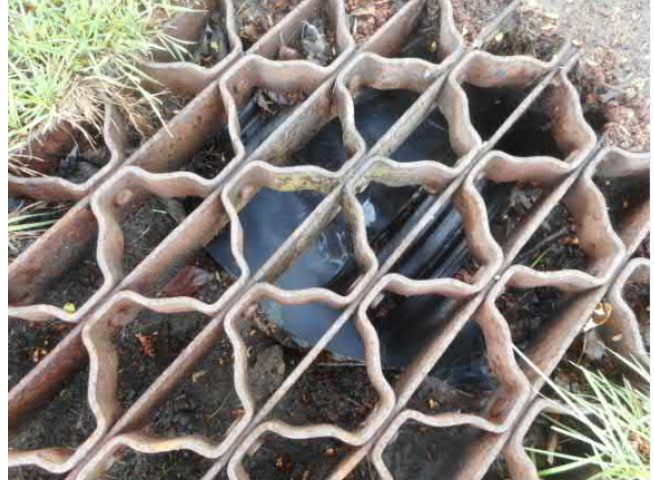
12 Adams Ave - Lots of smoke out of catch basin in front yard.

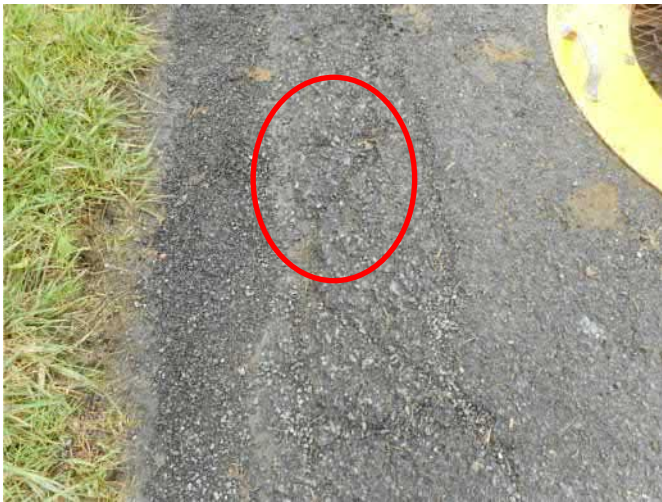
58 Adams Ave - Faint smoke from cracks in asphalt. Likely some sort of leak around frame in MH 12.

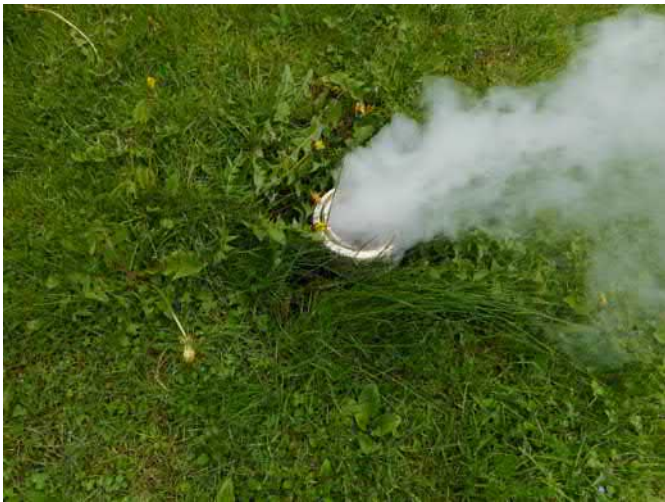
8 Van Duyne Ave - Uncapped cleanout below grade in side yard.

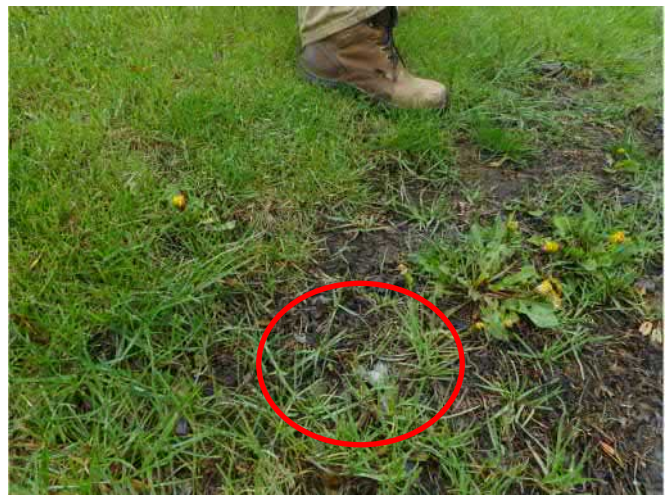
12 Van Duyne Ave - Smoke leaking out of ground next to MH 35.

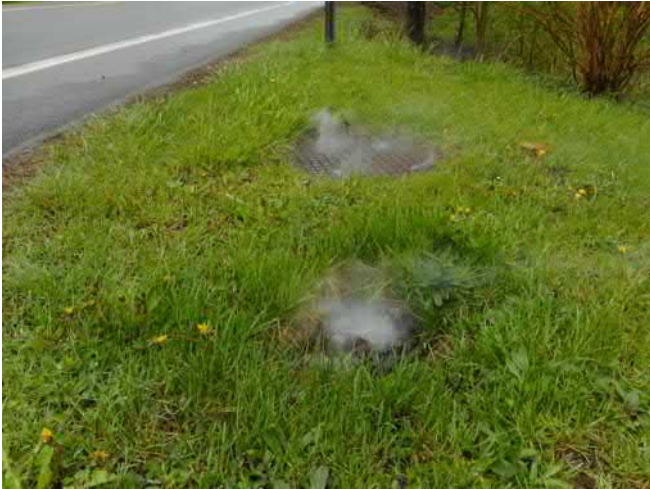
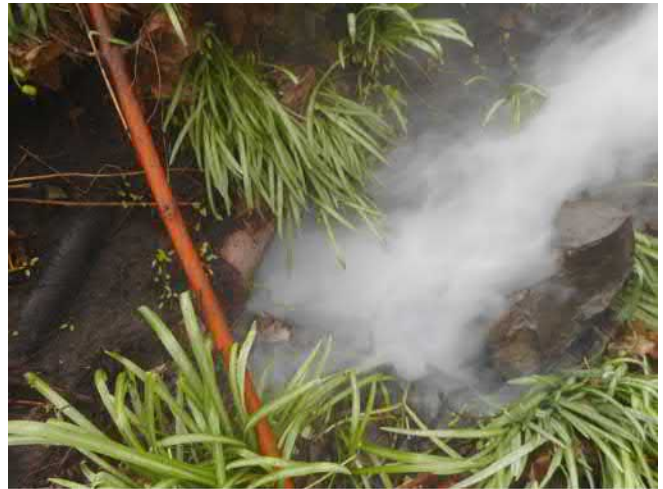
7074 Owasco Rd - Smoke coming out of hole around MH 2. Smoke out of poorly covered opening at bank of nearby creek.

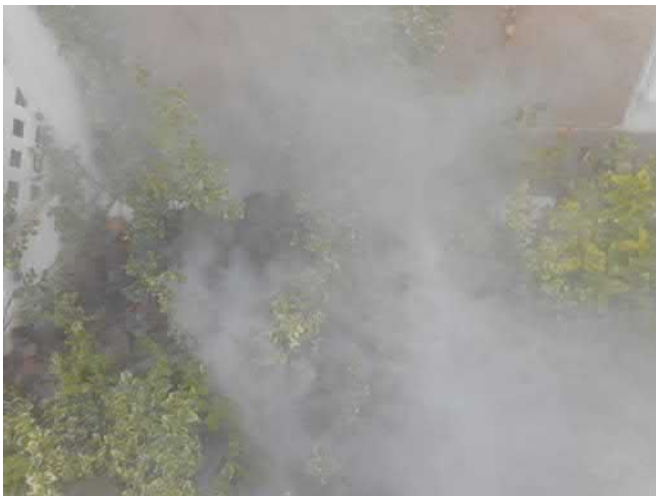
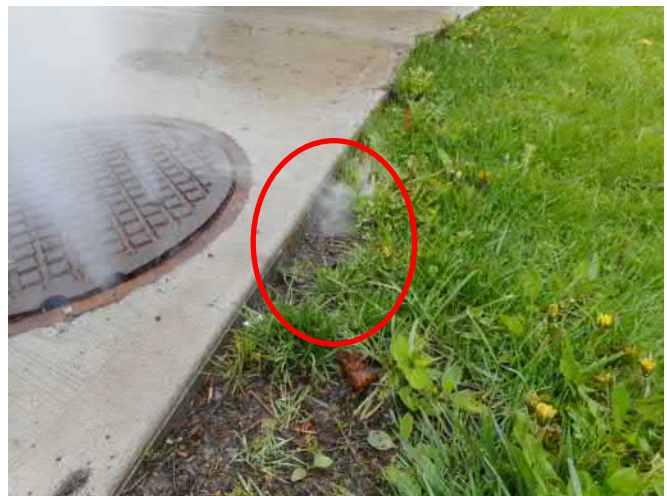
78 Hazelhurst Ave - Uncapped cleanout at grade in front landscaping. Smoke escaping under driveway. Likely a leak in MH 25.

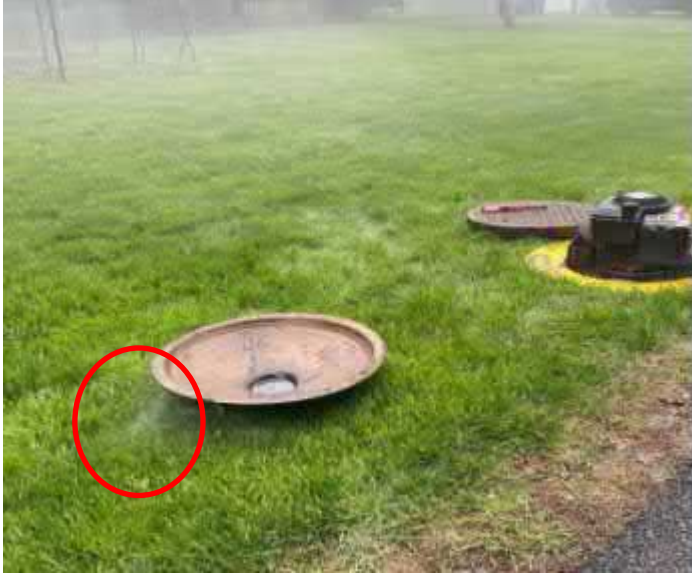
62 Hazelhust - Faint smoke from ground near MH 24. Likely cracked sewer pipe.

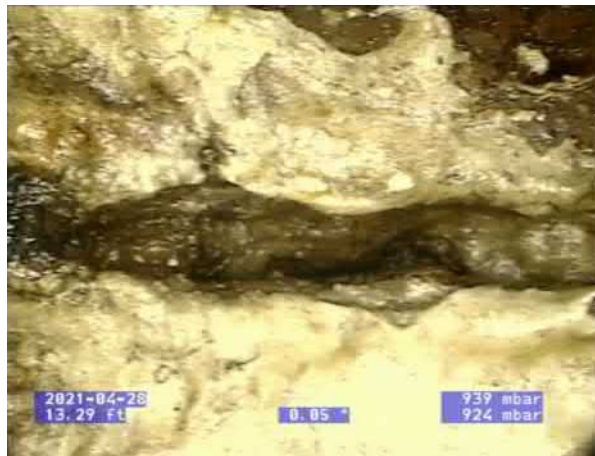
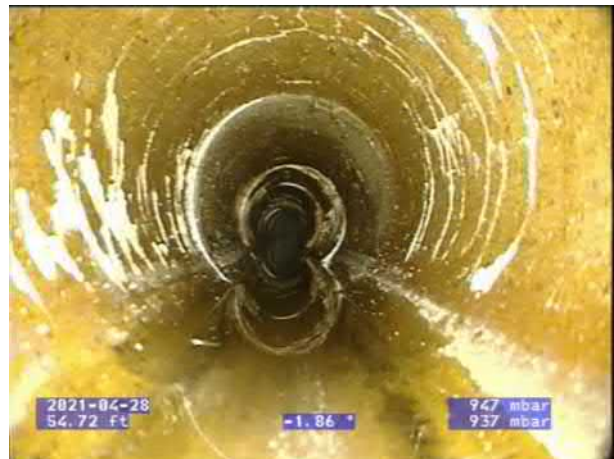
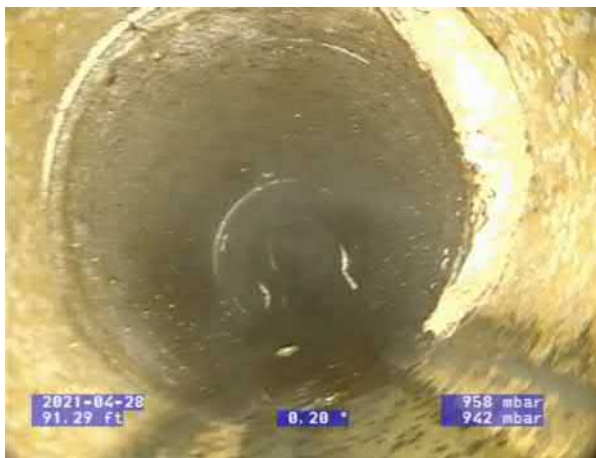
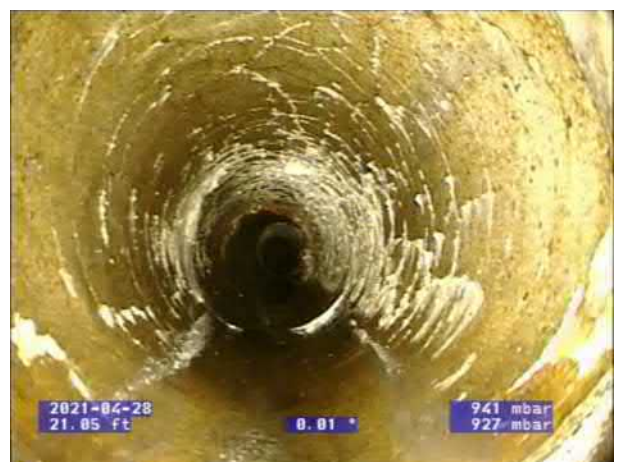
Manhole 1-25 to 1-24

- Several sections of full circumferential cracking (6)
- Joint offset at 91' from MH 1-25
- Longitudinal cracking (6)

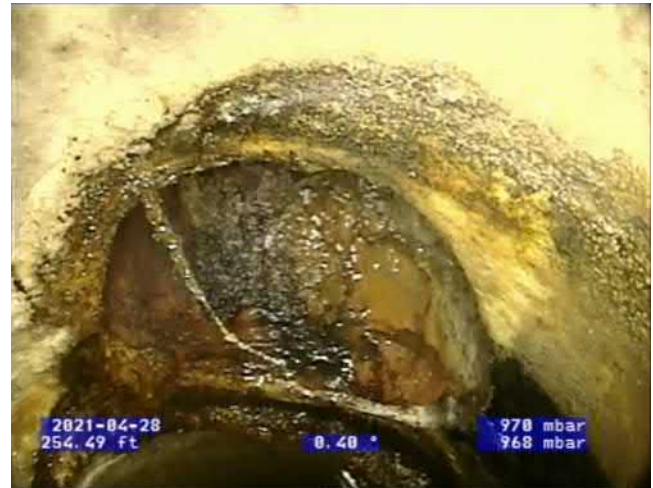
Manhole 1-26 to 1-25

- Spot crack 170' from MH 1-26
- Active leak around penetration of lateral (254')
- Dip in pipe right before MH 1-25
