Preliminary Engineering Report

Inflow and Infiltration Reduction Improvements

Town of Owasco

June 2021

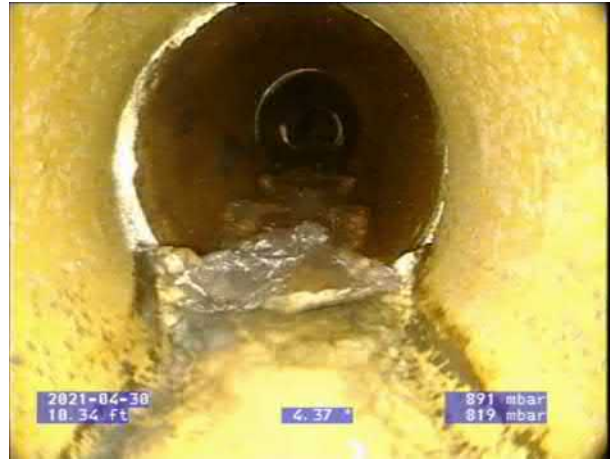
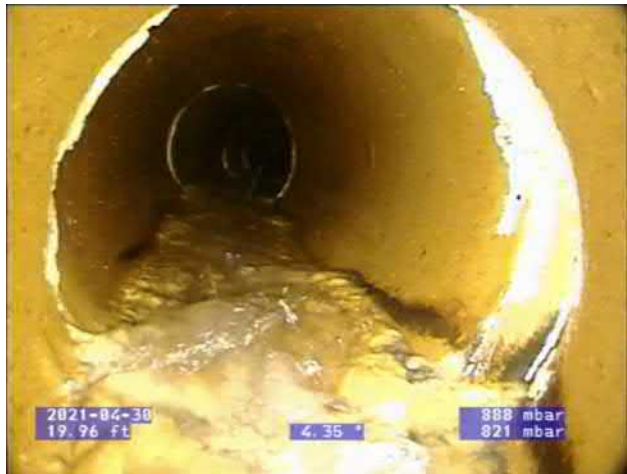
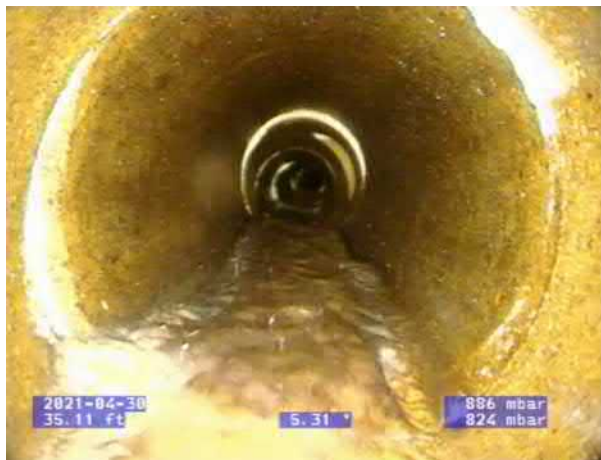
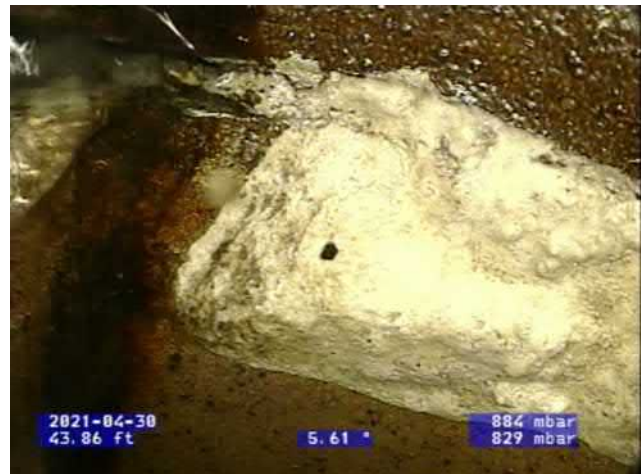
Manhole 4-32 to 4-33

- Offset joints with active leaking (23)
- Mineral buildup at joint 8' from MH 4-32
- Spot crack 255' from MH 4-32
