Preliminary Engineering Report

Inflow and Infiltration Reduction Improvements

Town of Owasco

June 2021

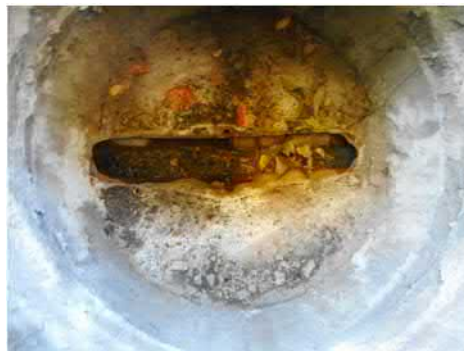
Manhole 2-14: Deposits on Bench/Channel

- ii. Recommended Rehabilitation Method: A cementitious coating can seal leaking walls/joints, provide structural support, and significantly extend the life of block/brick structures. Construction practices include first applying/ injecting a grout sealant to plug and stop active leaks in advance of the coating. The manhole would then generally be cleaned using a high pressure power washer to maximize the life of the coating system. The manhole walls, corbel, and bench would then be spin casted with a cementitious coating system. The finished product would look similar to the manhole pictured below, and provide a monolithic structural liner within the manhole.
