Preliminary Engineering Report

Inflow and Infiltration Reduction Improvements

Town of Owasco

June 2021

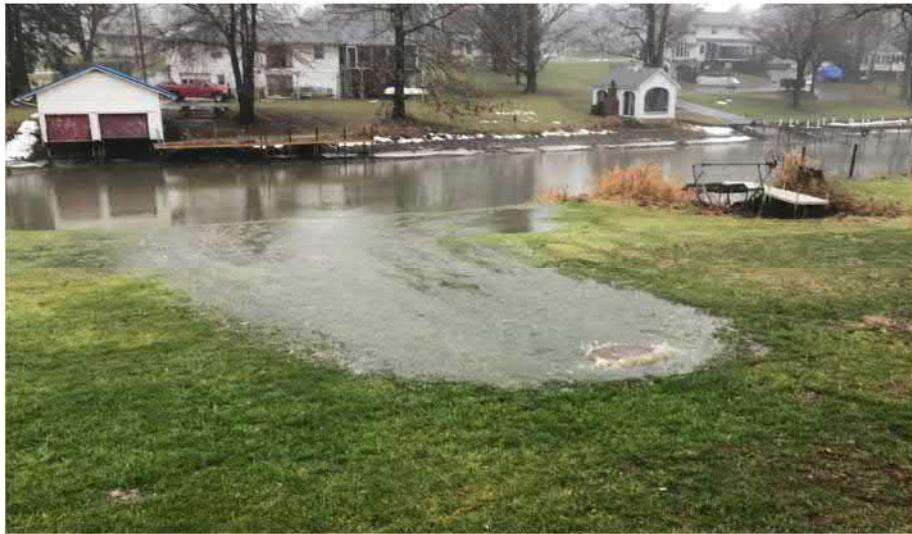
The Town of Owasco has a history of sanitary sewer overflows (SSOs). These SSOs have principally occurred along the Owasco Interceptor during heavy precipitation or thaw events when a seasonal high water table is present, and result in discharge of untreated wastewater to the adjacent Owasco Outlet. Since 2018, four (4) SSOs have been reported to the NYSDEC by the Town of Owasco. The full list of SSOs in the Owasco Sewer system are shown in detail in Appendix C.

Manhole along Owasco Interceptor Overflowing into Owasco Outlet

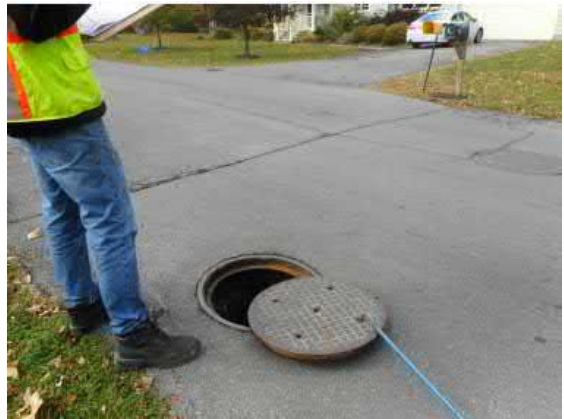
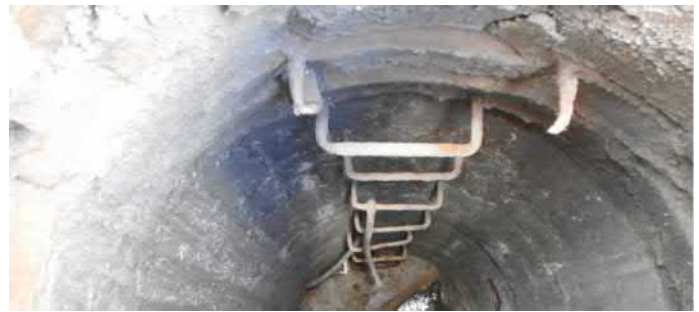
Manhole No. 1-0

- Possible abandoned lateral up wall
- Unknown hose connection
- Deteriorated riser
- Streaking on wall under steps, possible leak

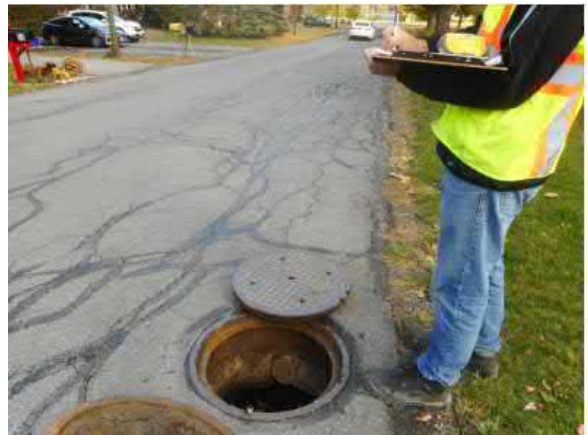
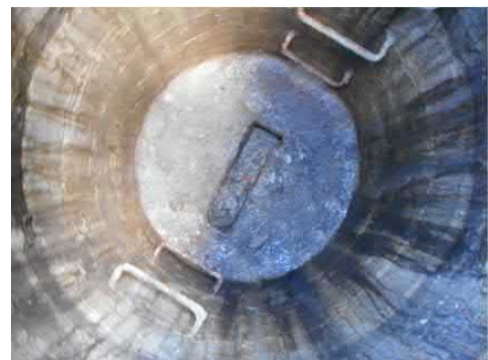
Manhole No. 1-2

- Lots of streaking on walls showing evidence of I/I
- Inflow dish with holes
- Deteriorated riser

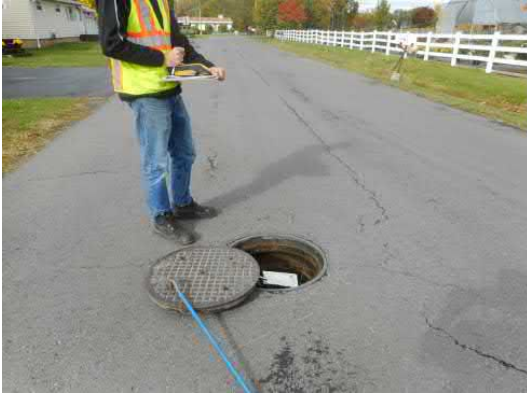
Manhole No. 1-4

- Very wet bench, potential active leak at wall/bench connection
- Streaking on walls from single wall joint

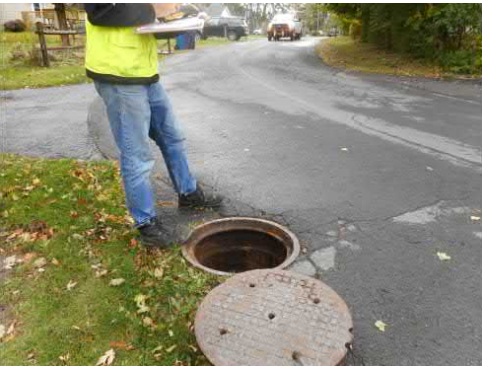
Manhole No. 1-11

- Inflow dish has fallen to bottom of manhole
- Channel in poor condition

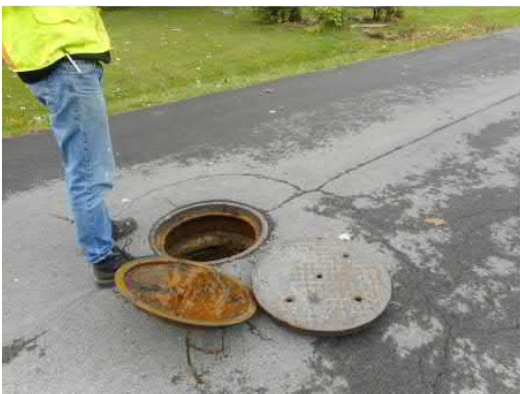
Manhole No. 1-12

- Lots of water sitting on bench, most likely from streaking down walls
- Brick manhole with lots of sediment buildup around walls

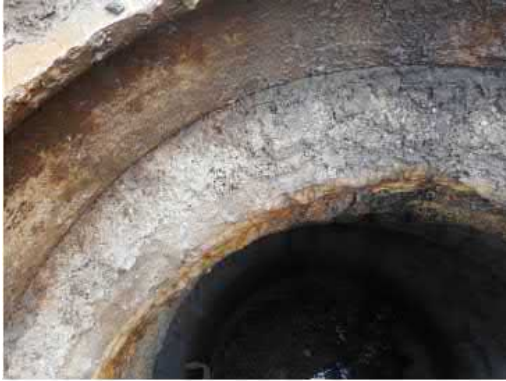
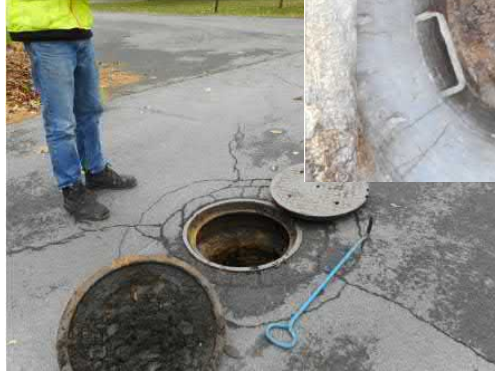
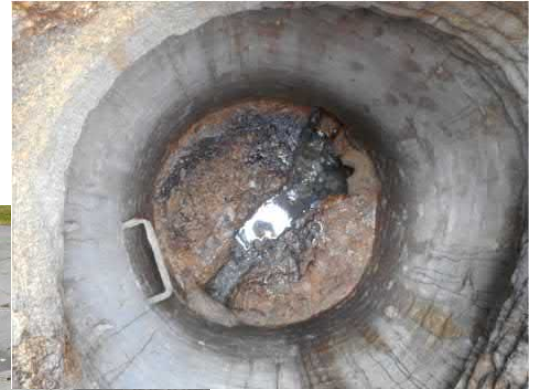
Manhole No. 1-14

- Bench and channel in poor condition
- Inflow dish with holes
- Deteriorated riser

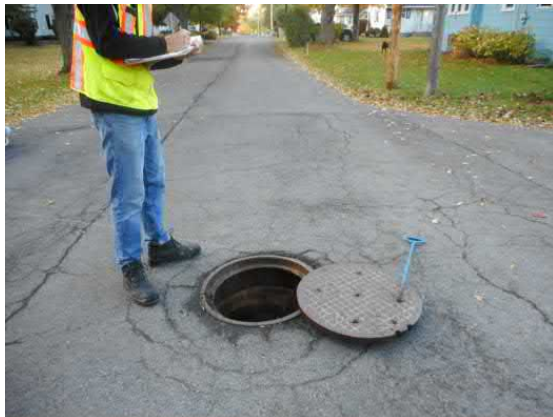
Manhole No. 1-26

- Water leaking in through joints and pipe penetrations

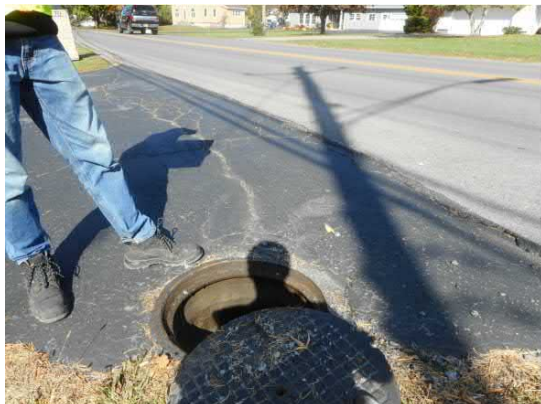
Manhole No. 1-32

- Abandoned pipe on wall, possible from nearby storm culvert

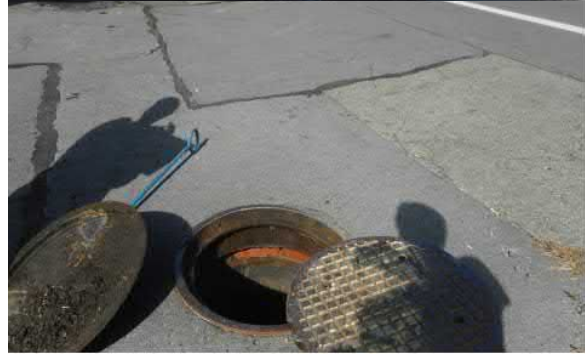
Manhole No. 2-2

- Leak around lateral penetration up the wall
- Water leaking through brick riser

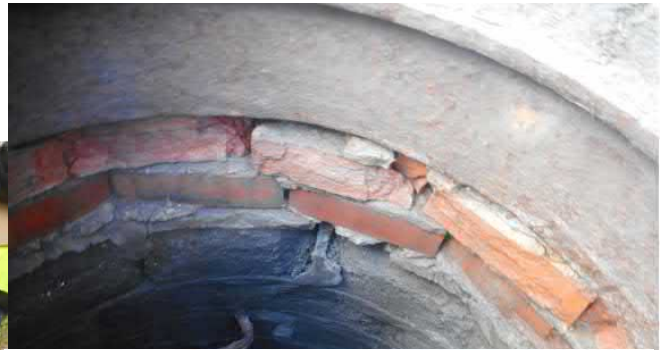
Manhole No. 2-3

- Water leaking through brick riser
- Potential for ponding from road runoff

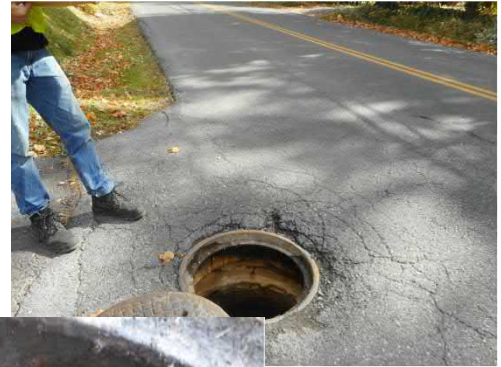
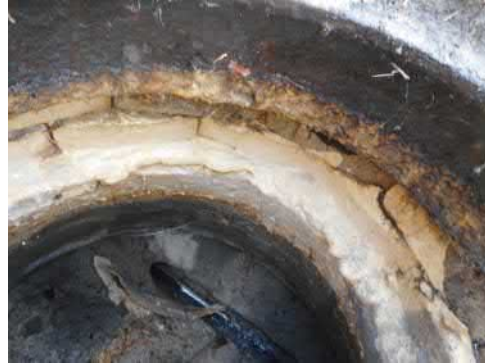
Manhole No. 2-6

- Past lining starting to deteriorate
- Frame/riser in poor condition
- Leak on bench

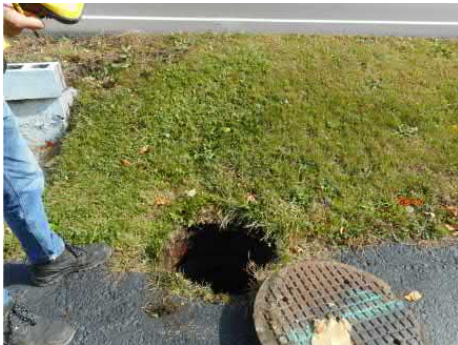
Manhole No. 2-11

- Potential for ponding
- Leak at wall joints
- Deteriorated and leaking walls

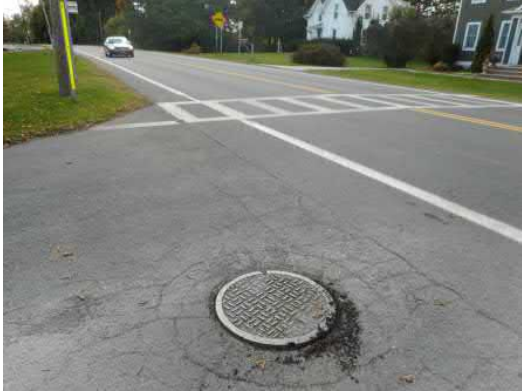
Manhole No. 3-20

- Potential for ponding
- Leaking through frame/riser

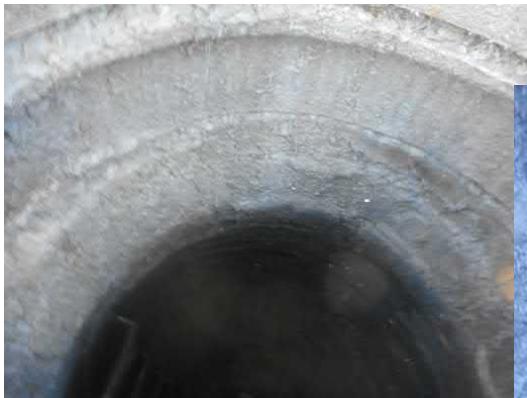
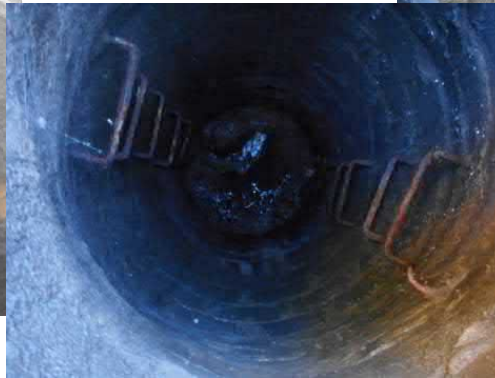
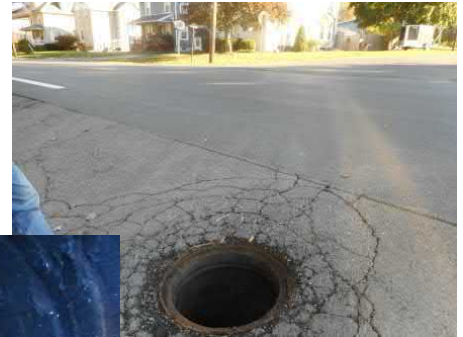
Manhole No. 3-27

- Loose fitting cover with water able to flow in
- Sediment buildup on frame/riser

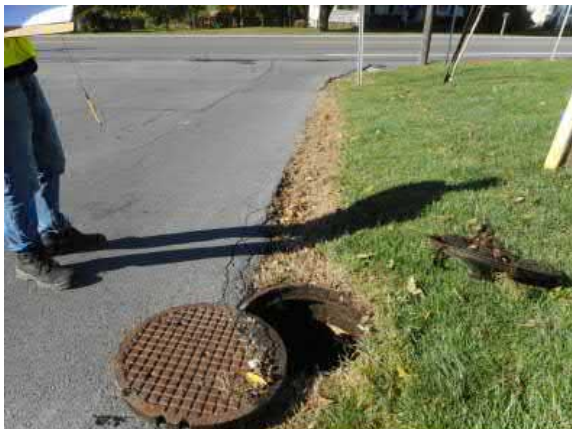
Manhole No. 3-34

- Roots penetrating through frame and walls
- Deterioration of frame

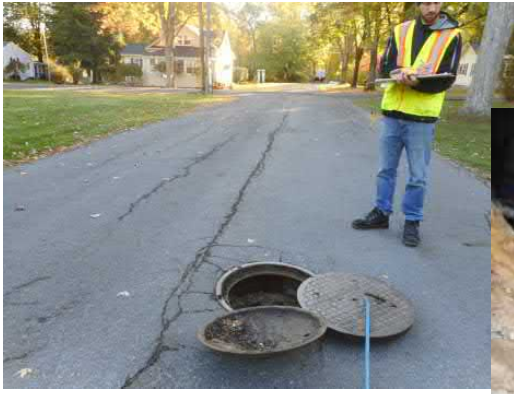
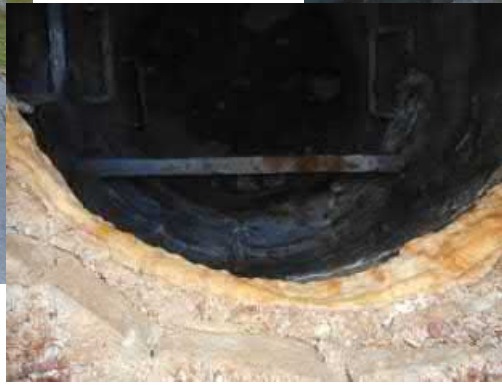
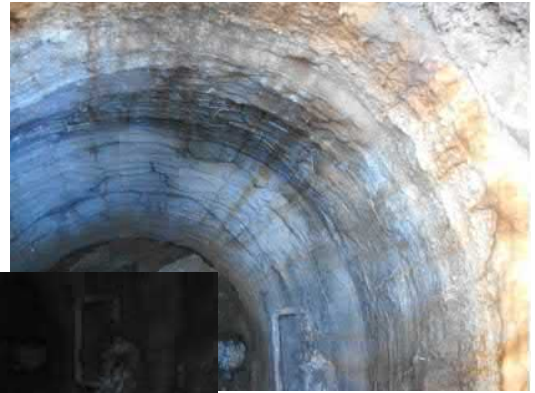
Manhole No. 3-42

- Unknown pipe through manhole
- Past lining deteriorated
- Inflow dish with holes

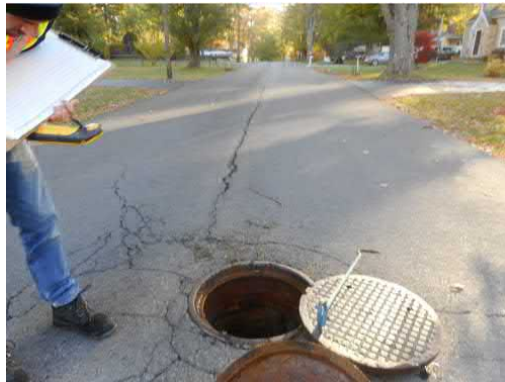
Manhole No. 3-43

- Past lining fully deteriorated

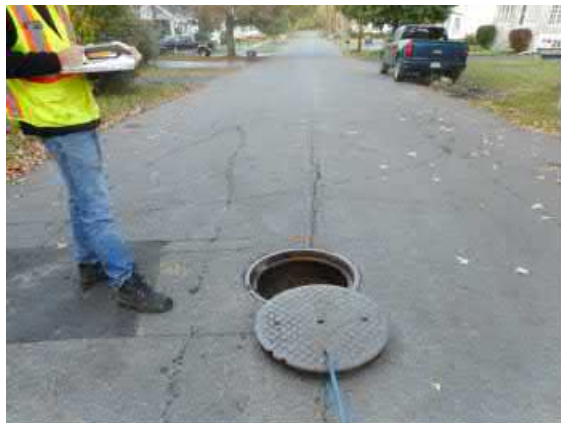
Manhole No. 3-47

- Large sediment buildup on riser/frame joint
- Active leak around lateral penetration (not pictured)

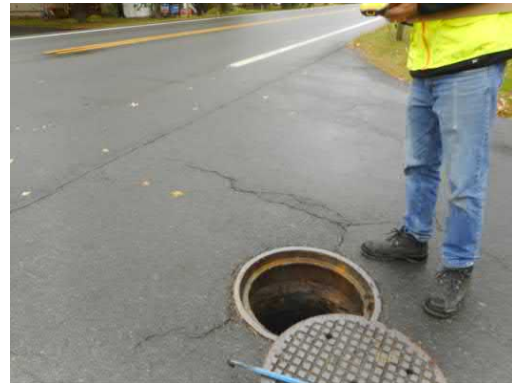
Manhole No. 4-2

- Three abandoned pipes along wall
- Frame/riser in poor condition

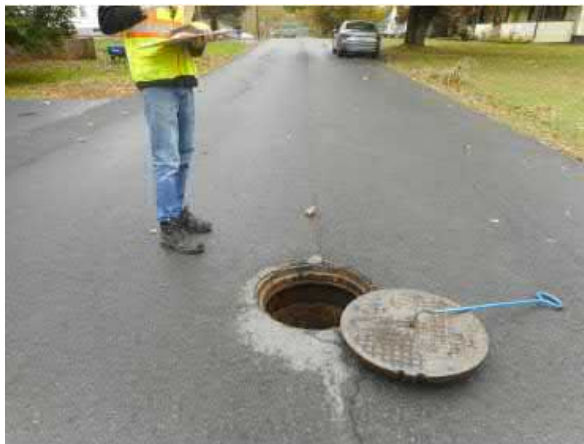
Manhole No. 4-19

- Debris on bench
- Deteriorated frame/riser

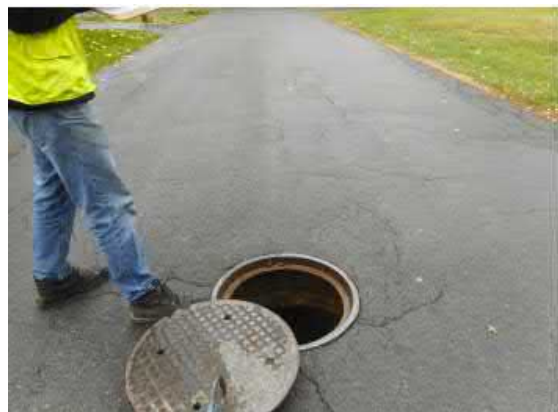
Manhole No. 4-32

- Block from wall has fallen onto bench
- Deterioration of rest of wall

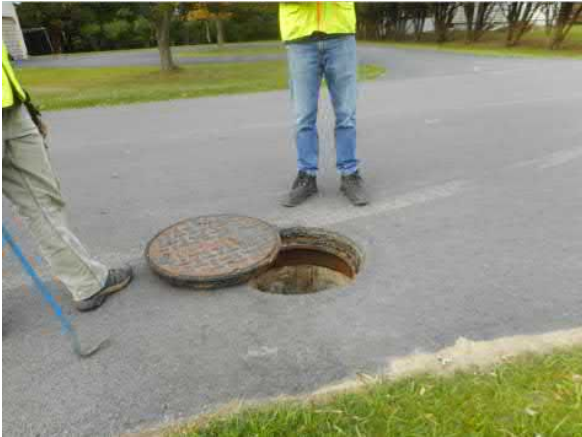
Manhole No. 5-13

- Streaking from leak on wall
- Lots of debris on bench

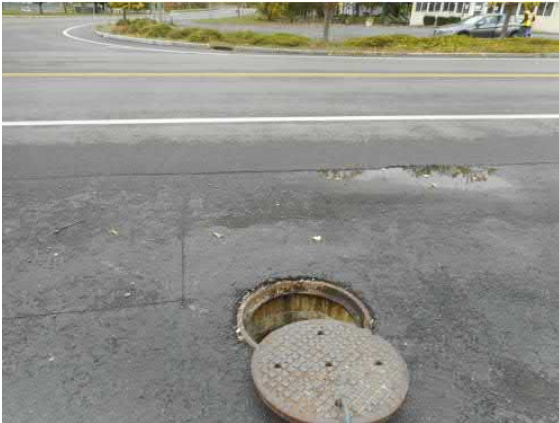
Manhole No. 6-12

- Receives force main from Sewer District 2
- Old lining falling completely peeling off
- Bench and channel in poor condition

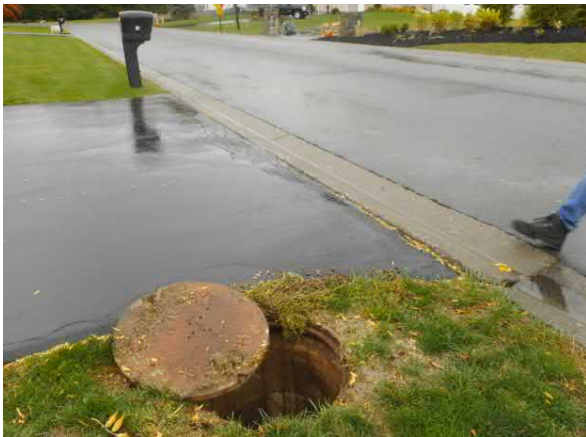
Manhole No. 6-40

- Streaking below steps, potential active leak at bench/wall joint
- Leaking around joints of wall/corbel

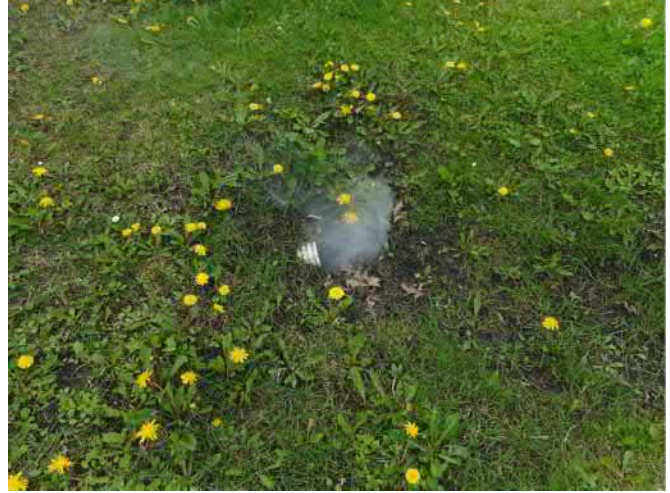
29 3rd Ave - Smoke from pipe in drainage pipe near MH 43. Possible connection to sewer piping.

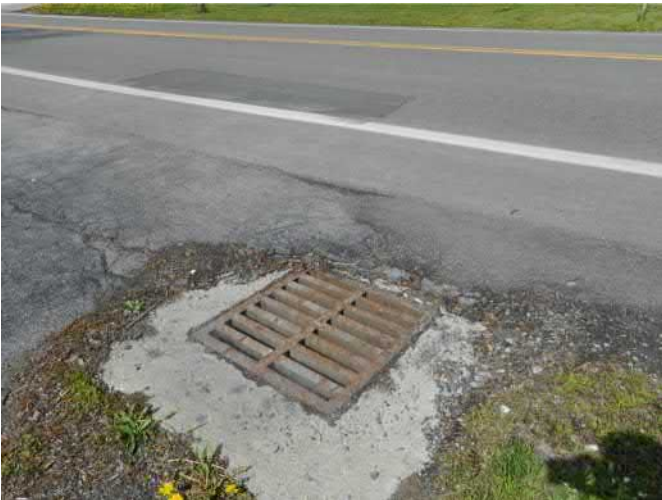
7291 Owasco Rd - Faint smoke from catch basin next to MH 31.

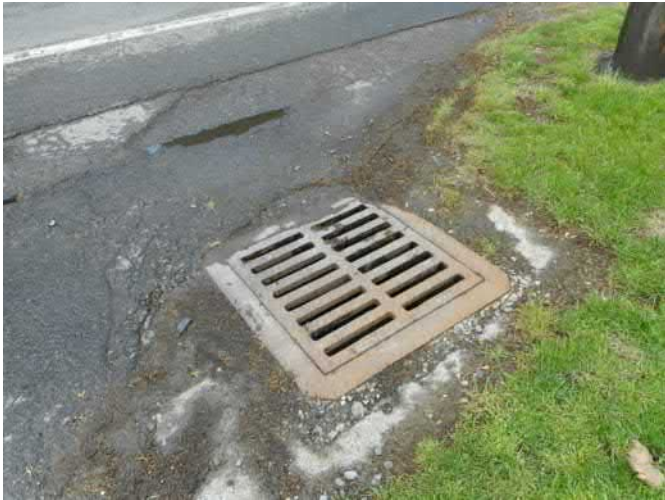
Sub-Area 3

7218 Owasco Rd - Faint smoke from catch basin next to MH 21.

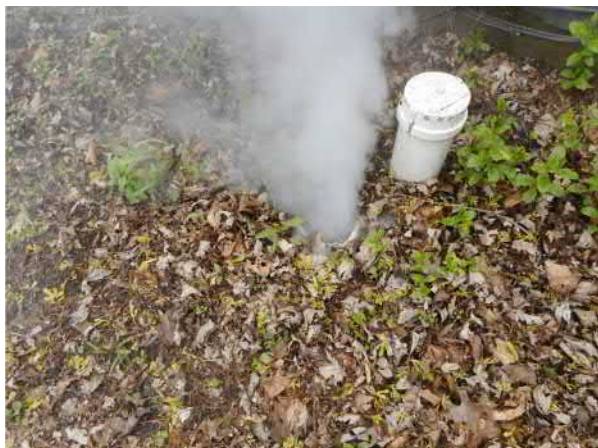
Sub-Area 1

67 1st Ave - Uncapped cleanout below grade.

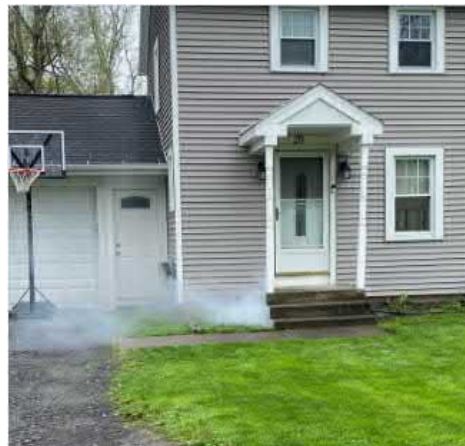
Sub-Area 4

20 Van Duyne Ave - Uncapped cleanout at grade next to front steps.

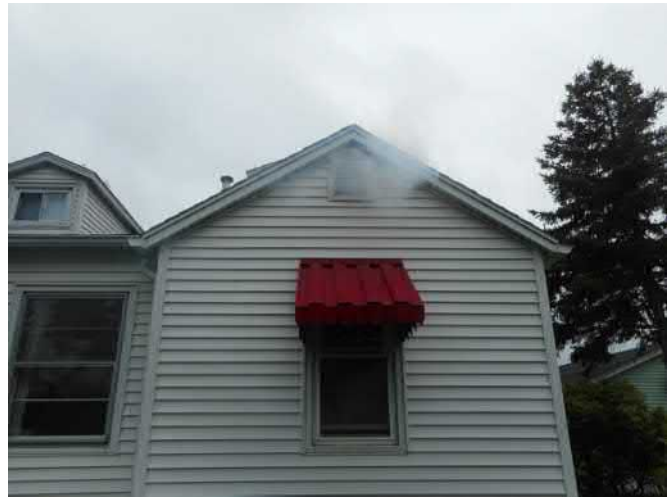
16 Aldrich Ave - Smoke out of vent above window.

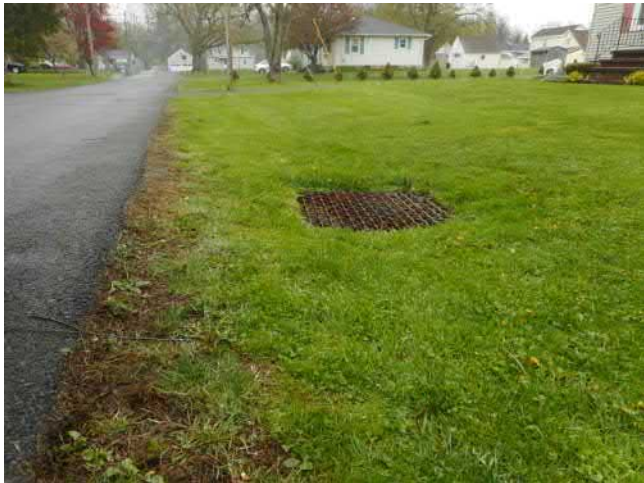
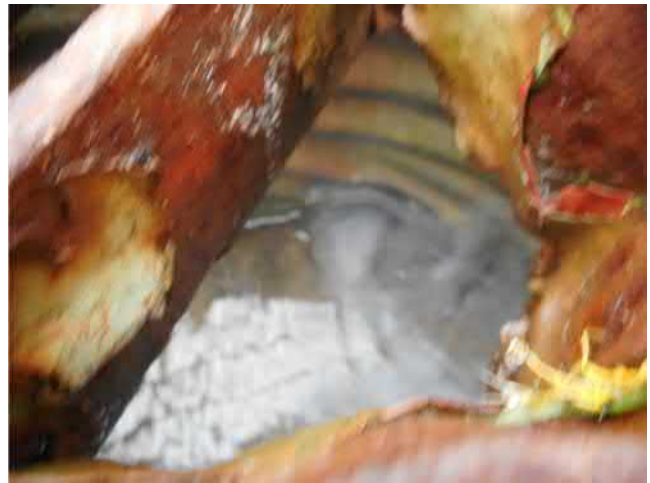
Sub-Area 4

56 Van Duyne Ave - Lots of smoke out of catch basin in front yard. Smoke looks to be coming directly out of storm pipe. Possible connection to sewer piping.

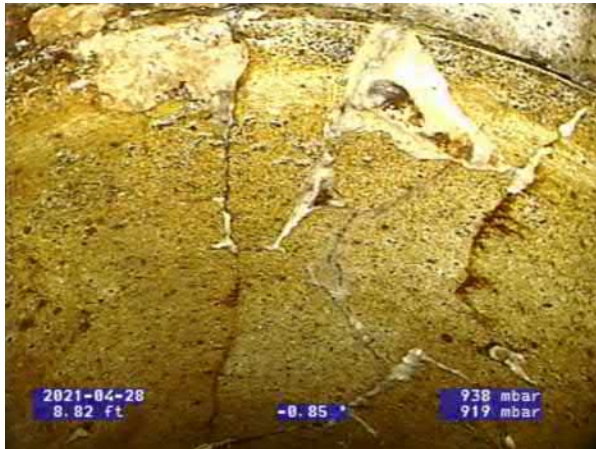
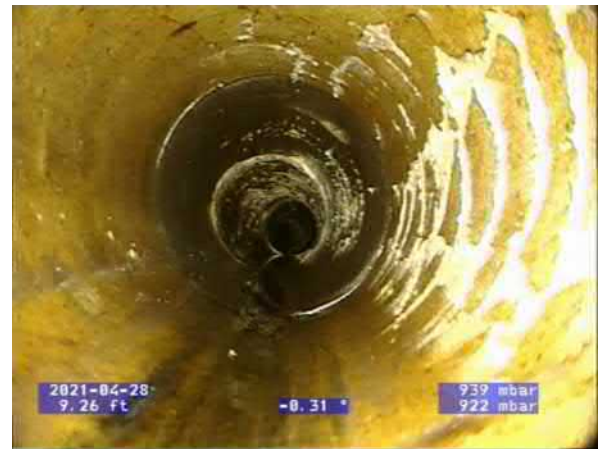
Manhole 1-25 to 1-24

- Several sections of full circumferential cracking (6)
- Joint offset at 91' from MH 1-25
- Longitudinal cracking (6)

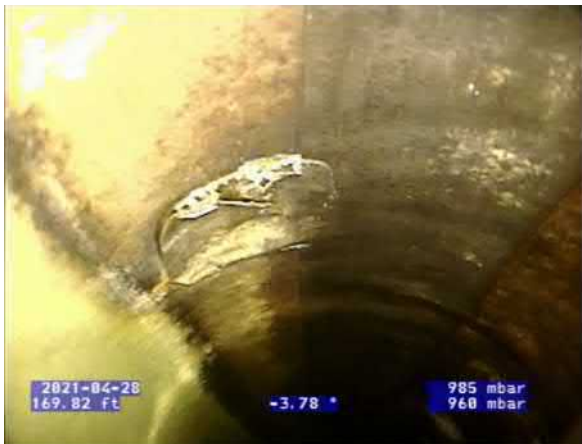
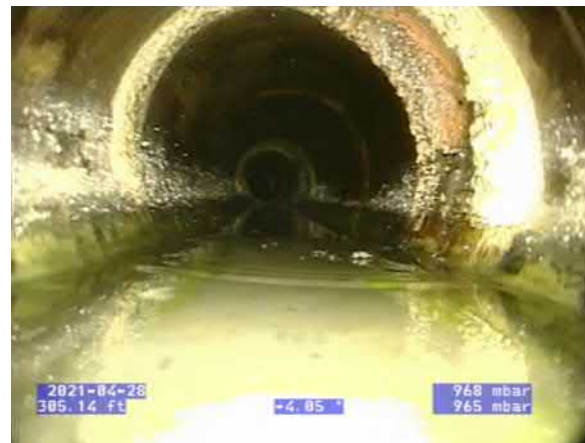
Manhole 1-26 to 1-25

- Spot crack 170' from MH 1-26
- Active leak around penetration of lateral (254')
- Dip in pipe right before MH 1-25

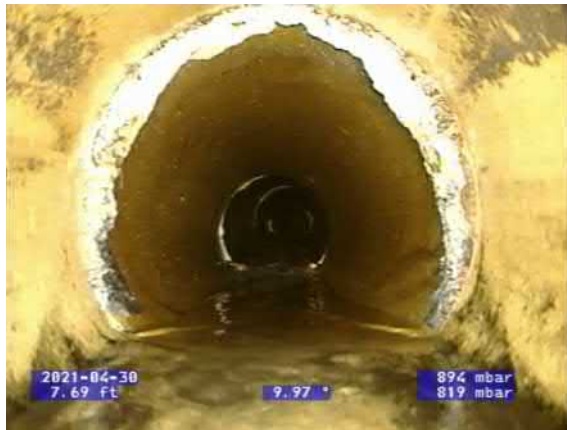
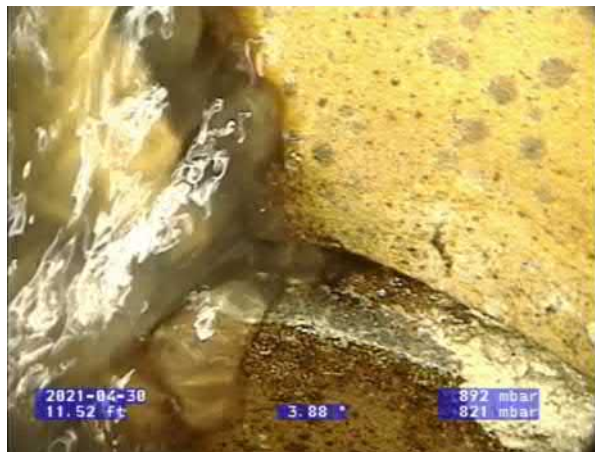
Manhole 4-32 to 4-33

- Offset joints with active leaking (23)
- Mineral buildup at joint 8' from MH 4-32
- Spot crack 255' from MH 4-32

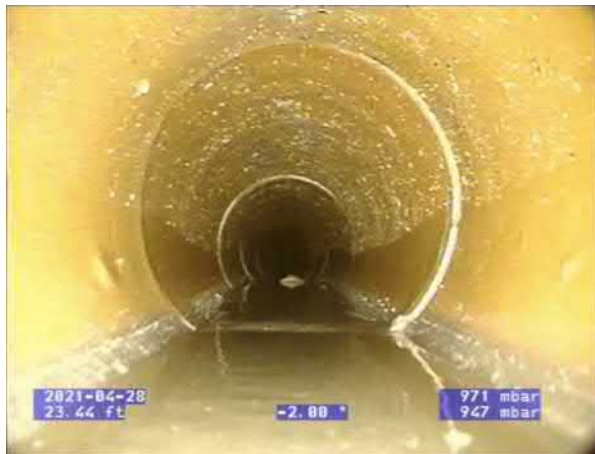
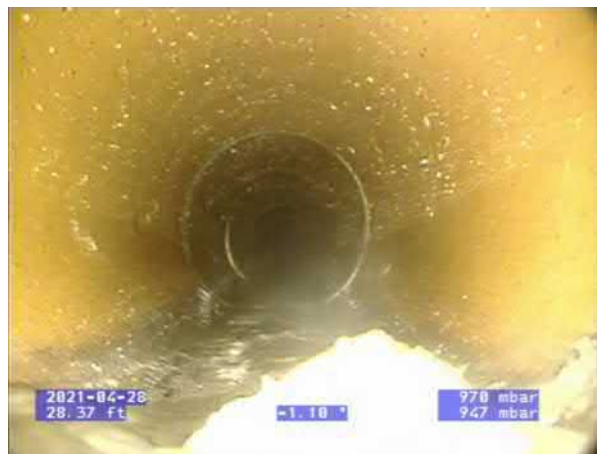
Manhole 4-34 to 4-35

- Debris in pipe 28' from MH 4-34
- Survey abandoned at 46'

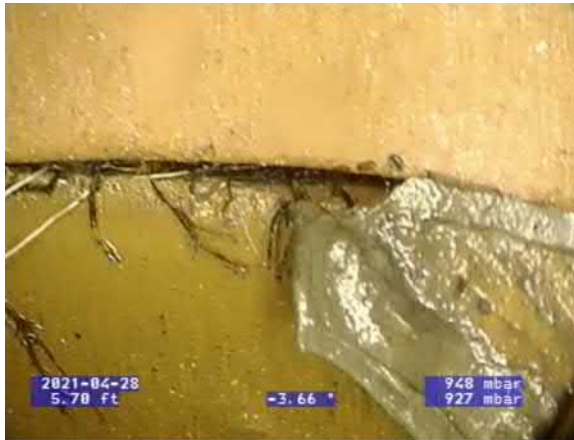
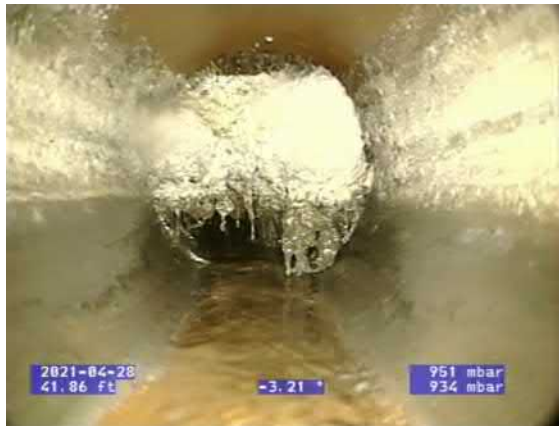
Manhole 4-35 to 4-36

- Active leak at offset joint at 6'
- Roots breaking in at offset joint at 9'
- Survey abandoned at 42' due to a root blockage
